Fish deaths in the Darling–Baaka River – Part B

Part B of the submission to the OCSE independent review into the February to March 2023 fish deaths in the Darling–Baaka River, Menindee

July 2023

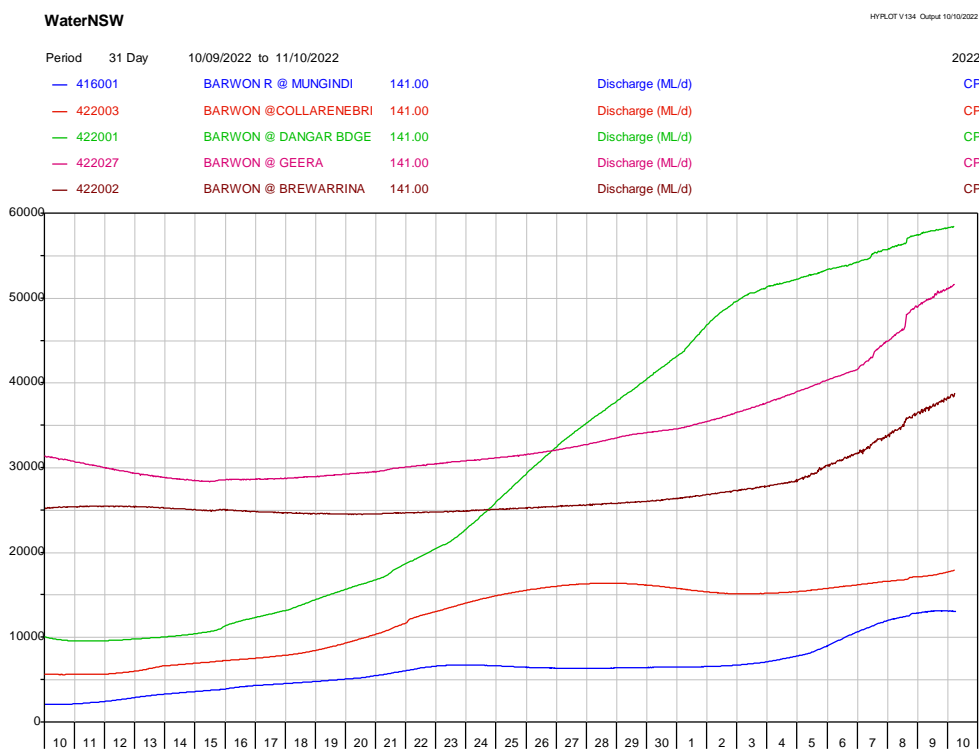
Figure 1. Discharge (ML/day) in the Barwon River

Discharge in the Barwon River at Walgett is over 58,000 ML/day from floodwater coming out of the Namoi Valley (Figure 1). Namoi River at Goangra is at a moderate flood level with more floodwater at Gunnedah and Narrabri. Flow is increasing at Geera and Brewarrina.

Dissolved oxygen at Collarenebri remains at safe ecological levels. The higher flows from the Namoi River have impacted dissolved oxygen levels at Walgett, and now Geera and Brewarrina (Figure 2). Water temperatures decreased over the weekend following widespread rain and cooler air temperatures (Figure 3). Sentinel images are showing the floodwaters from the Namoi River are turbid, rather than the distinct blackwater appearance observed during the November/December flood last year.

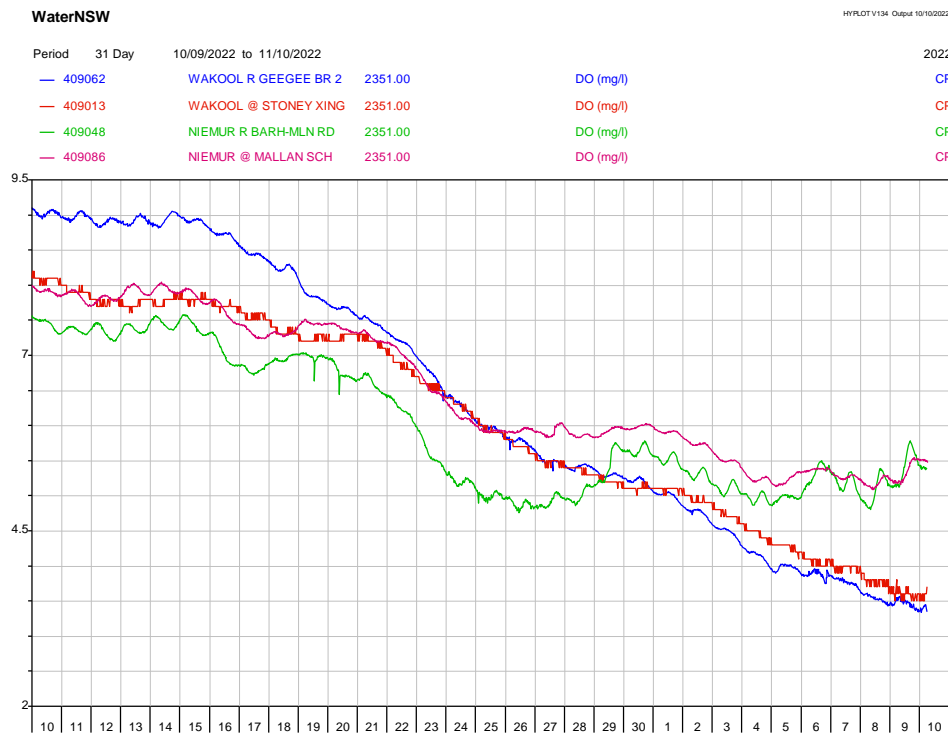
Figure 14: Continuous dissolved oxygen (mg/L) in the Wakool and Niemur Rivers

Floodwaters from the Murray River combined with floodwaters from the Edward River have caused minor flooding at Wakool Junction. The Wakool and Niemur rivers are currently flowing above 10,000 ML/day and rising. Conversely, dissolved oxygen has slowly been on the decline with both sites on the Wakool dropping below 4 mg/L (Figure 14).

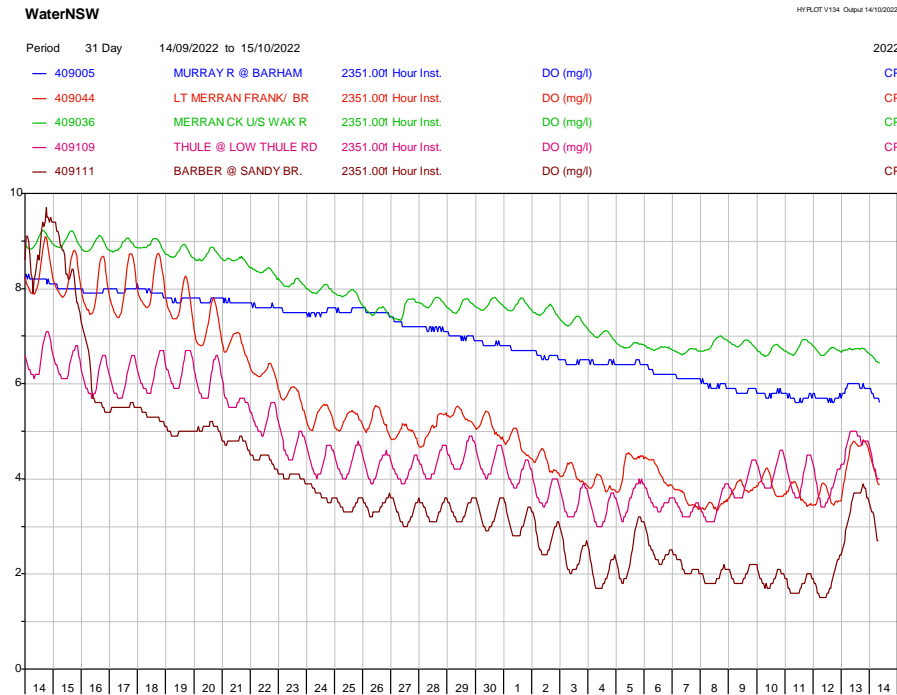
Figure 28: Continuous dissolved oxygen (mg/L) in the Murray River, Merran, Little Merran, Thule and Barber creeks

recovered in response to cooler weather conditions. Little Merran and Thule creeks are fluctuating around the 4 mg/L mark. The dissolved oxygen levels in the Murray River at Barham are showing minimal impact of any hypoxic outflows from Koondrook-Perricoota Forest.

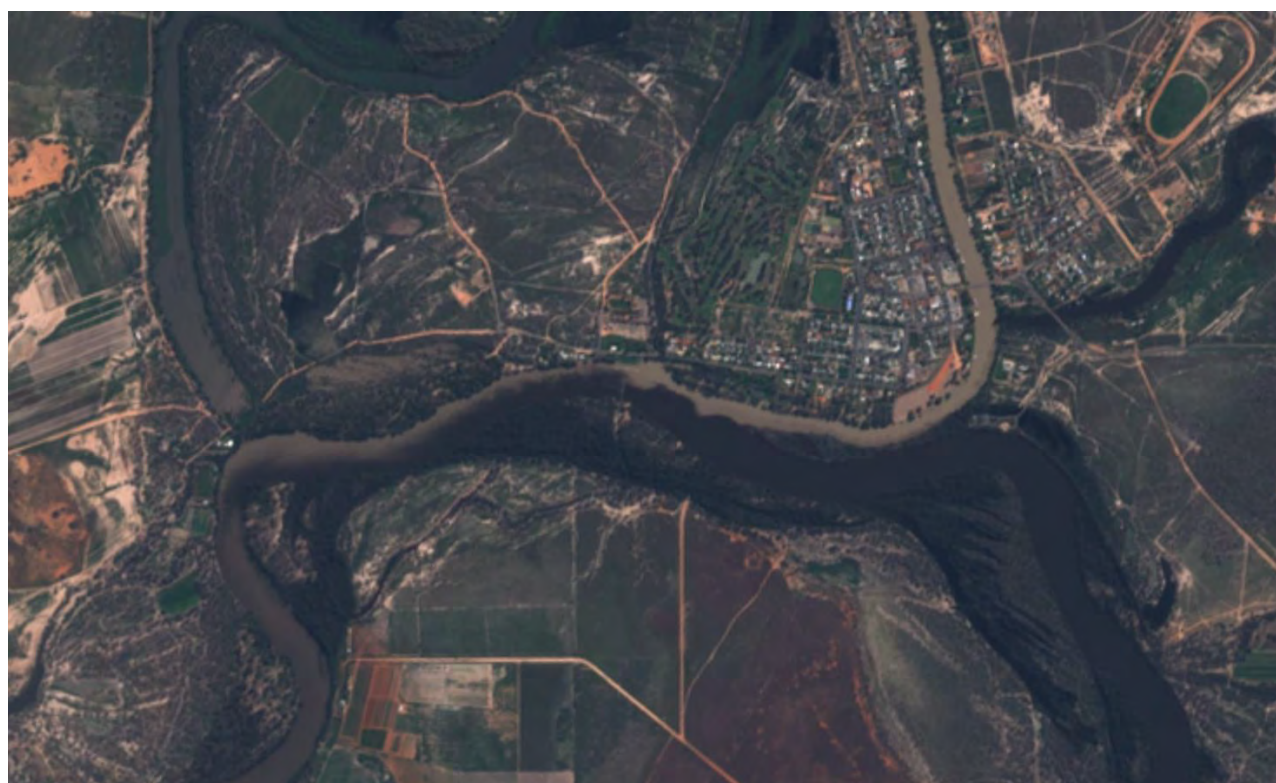
Figure 75: Sentinel image showing the junction of the Darling and Murray Rivers at Wentworth

Site	Sample date	Dissolved oxygen (mg/L)	Water temperature (°C)
Darling River Wentworth town bridge	27/10/2022	4.46	20.2
Murray River at Broken Hill pipeline station (2.5km U/S Lock 10)	27/10/2022	3.00	20.0
Murray River 100m D/S Lock 10, NSW side	27/10/2022	3.76	20.1
Murray River 100m D/S Lock 10, Vic side	27/10/2022	3.06	20.0
Murray River 3km D/S Lock 10 (turkey farm)	27/10/2022	3.26	20.0

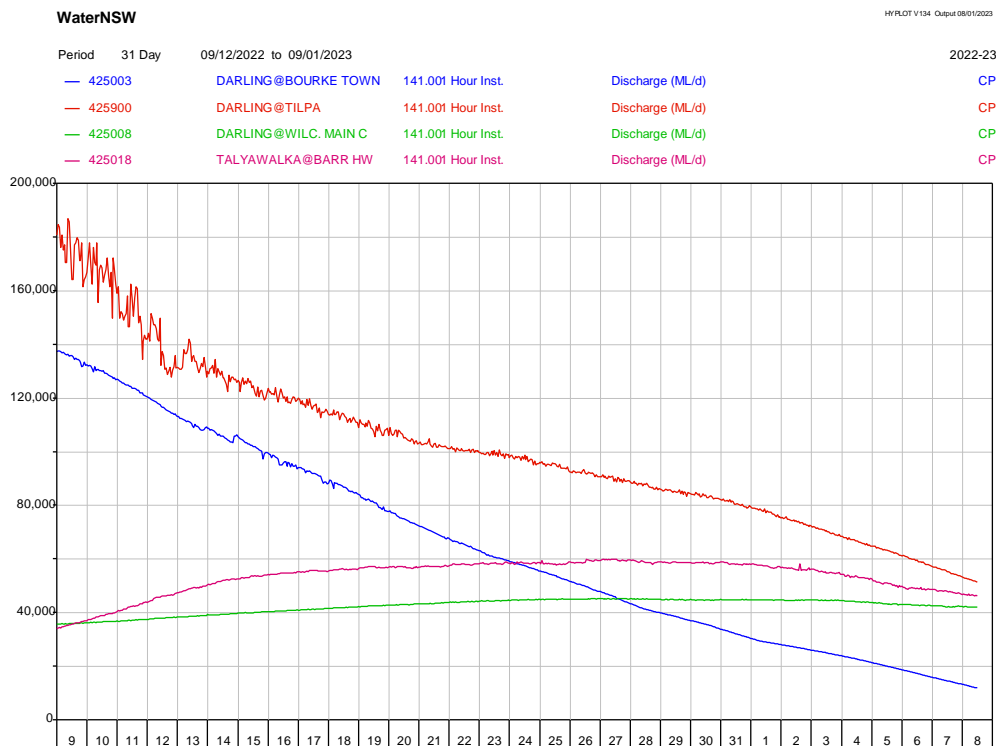
Figure 272: Discharge (ML/day) in the upper Darling River

Discharge at the Wilcannia gauge peaked at 50,000 ML/day while the flow in Talyawalka Creek has peaked at around 60,000 ML/day (Figure 272). Discharge is just over 17,800 ML/day at Burtundy. Major flood warnings continue for Tilpa, Wilcannia and Menindee.

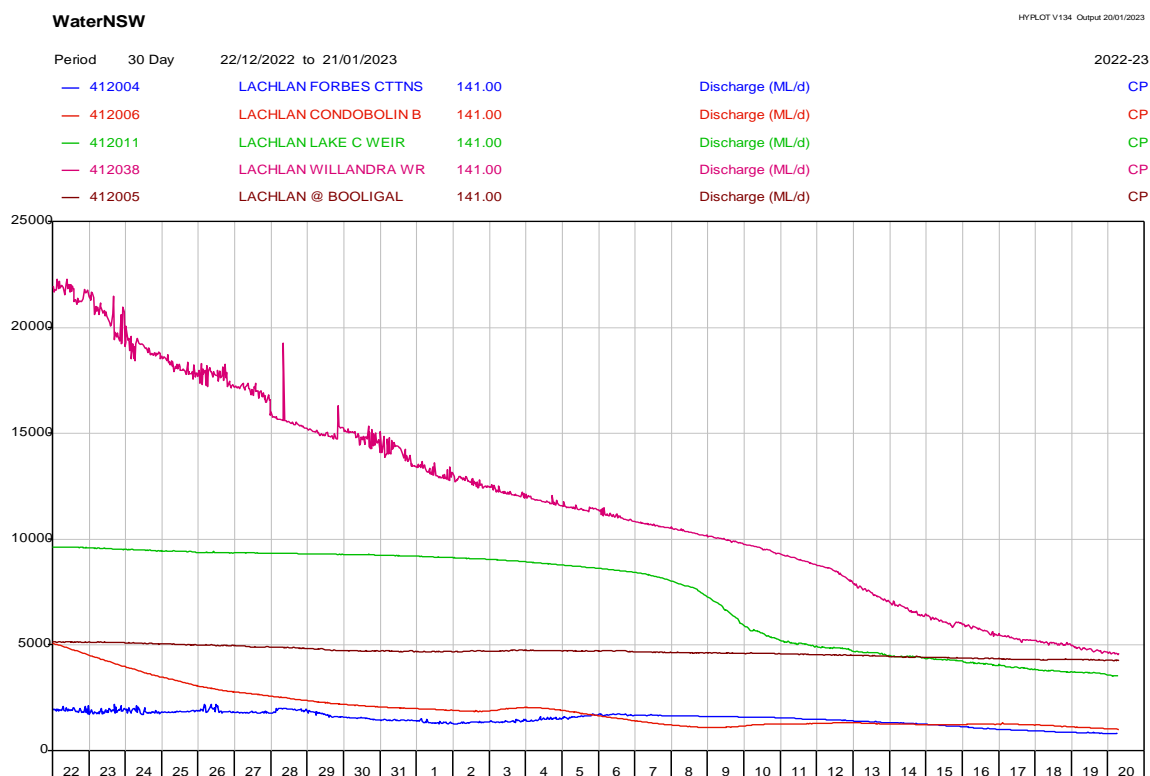
Figure 330: Discharge (ML/day) in the Lachlan River

Discharge in the Lachlan River at Willandra Weir is decreasing towards 4,500 ML/day (Figure 330). Minor flooding continues at Booligal and is expected to continue into late January. The Lachlan River at Hillston Weir is now below the minor flood level and continues to fall.

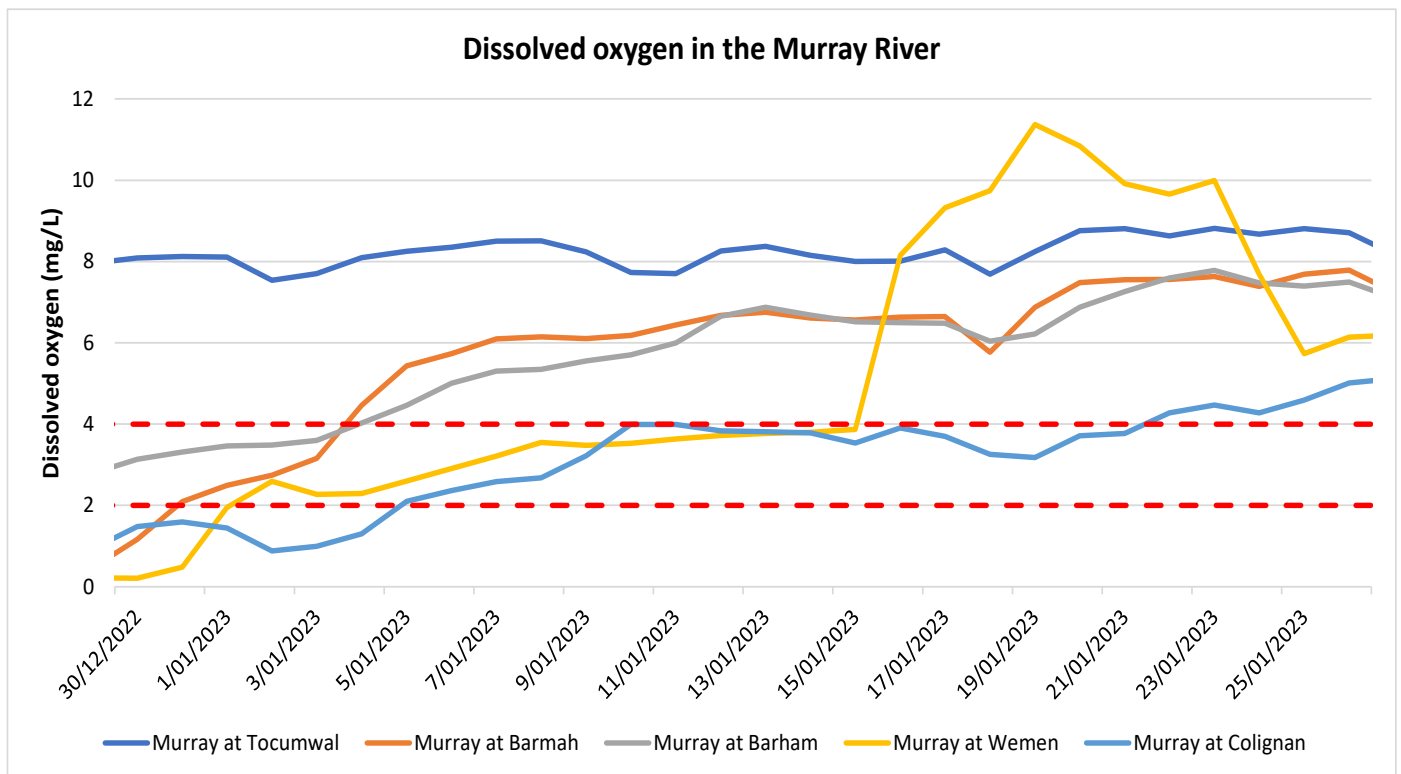
Figure 371: Continuous dissolved oxygen (mg/L) in the Murray River (data courtesy of DELWP)

The high dissolved oxygen results observed at Pental Island Pumps, Boundary Bend and Wemen appear to be due to the sensors coming out of the water.

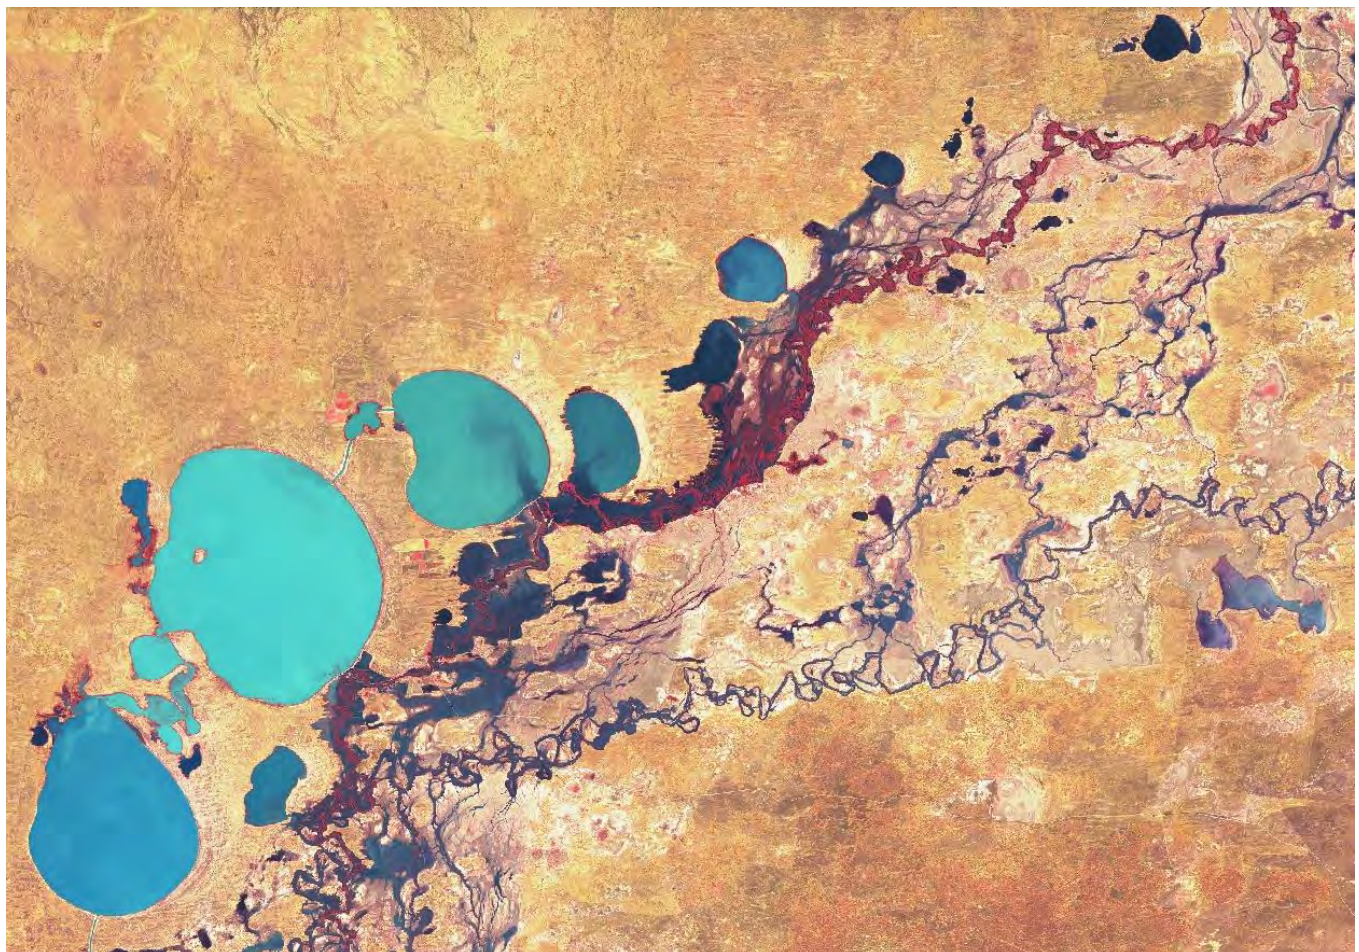
Figure 382: Satellite derived infrared image of Darling River and Menindee Lakes – 2 February 2023

Figure 382 is a satellite derived colour infrared Sentinel image of Darling River and Menindee Lakes on 2 February 2023, highlighting floodwater has largely returned to the main river channel. Some water is pushing from Lake Wetherell into Lakes Tandure and Pamamaroo.

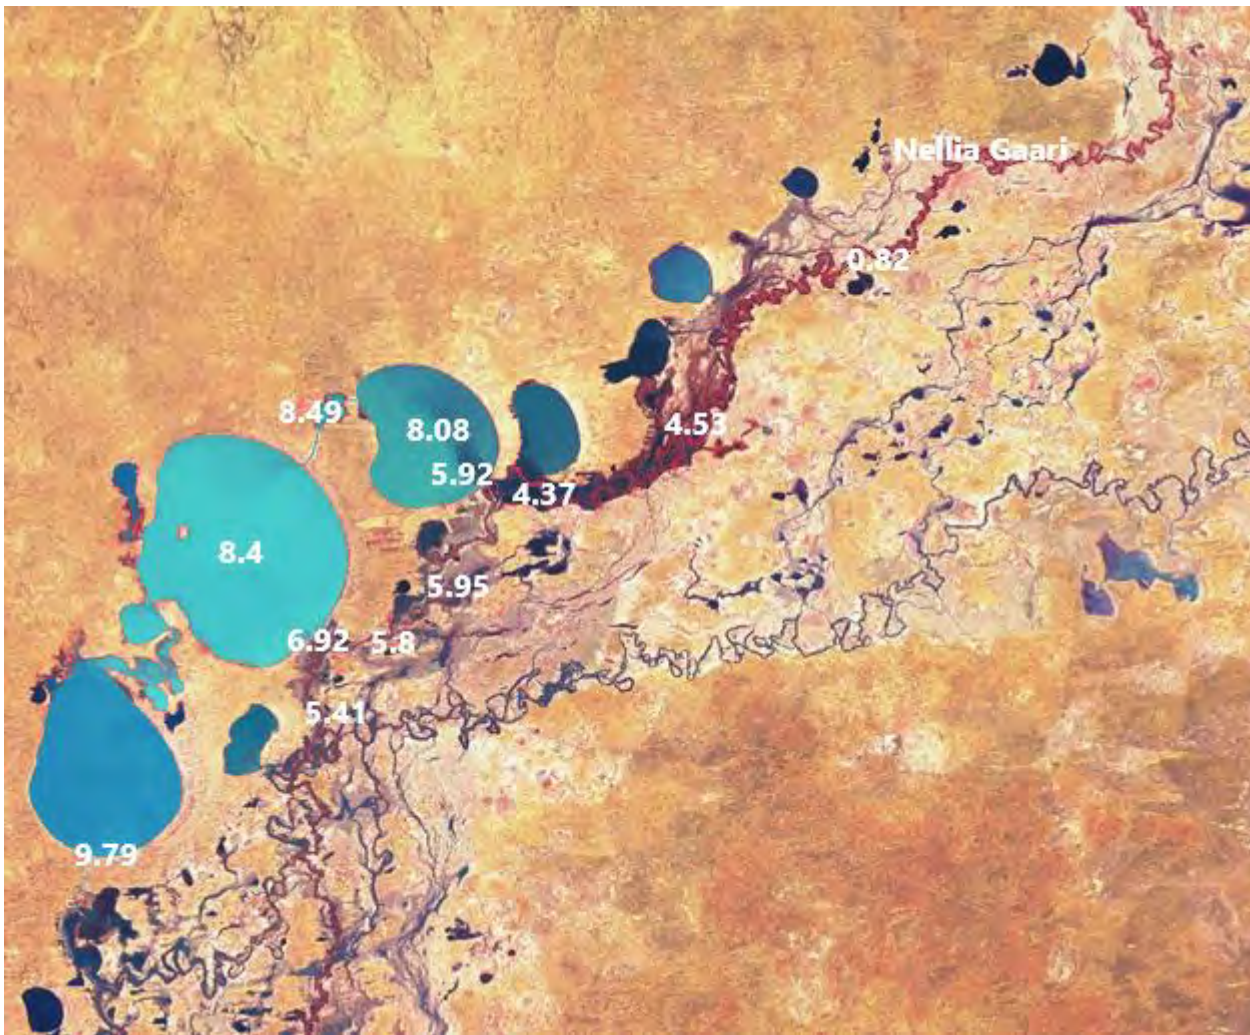
Figure 404: Satellite derived infrared image of Darling River and Menindee Lakes – 7 February 2023. Dissolved oxygen results (mg/L) collected 8 and 9 February 2023 (WaterNSW)

Figure 404 is a satellite derived colour infrared Sentinel image of Darling River and Menindee Lakes on 7 February 2023, highlighting floodwater has largely returned to the main river channel. Some water is pushing from Lake Wetherell into Lakes Tandure and Pamamaroo. Additional readings collected by WaterNSW on 8 and 9 February confirm low dissolved oxygen in the upper reaches of Lake Wetherell and more oxygenated water in the other lakes.

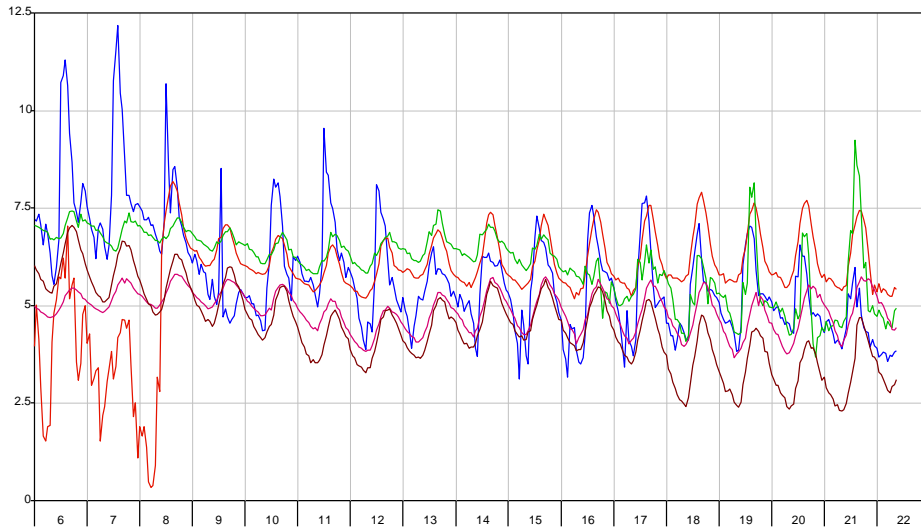
Figure 430: Continuous dissolved oxygen (mg/L) in the Lachlan River

Dissolved oxygen in the Lachlan River is above 4 mg/L at most monitoring sites. There are lower readings at Booligal, possibly as the last of the floodwaters drain back into the main channel (Figure 430Figure 8). Handheld readings taken downstream of Booligal at Corrong show low dissolved oxygen (Table 42). Water temperature is increasing above 25°C (Figure 431).

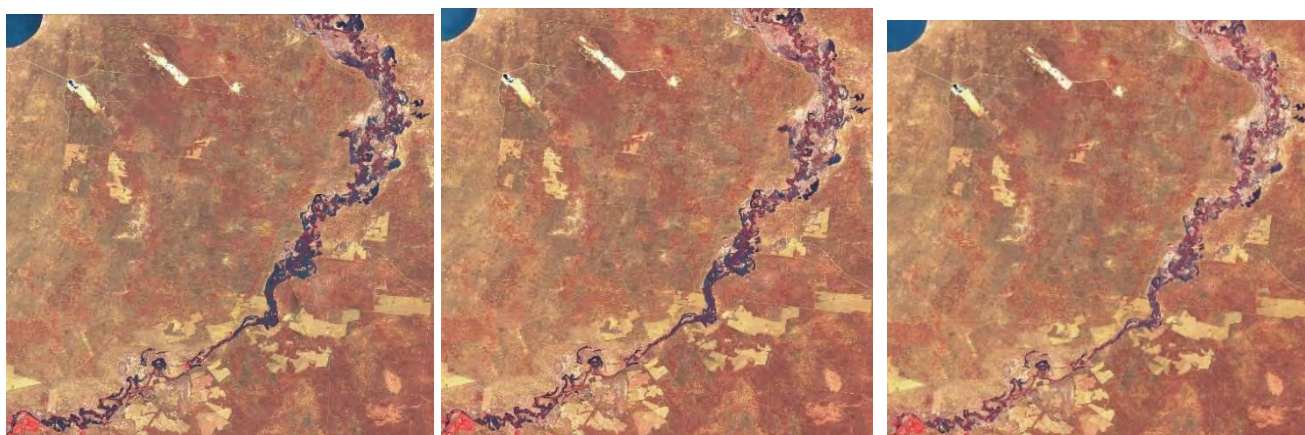
Figure 452: Satellite derived Sentinel colour infrared image of lower Darling River – Images 22 February (left), 27 February (middle), 4 March (right)

A series of satellite-derived Sentinel colour infrared images (Figure 452) from 22 February (left), 27 February (middle) and 4 March (right) highlights the draining of floodwater off the Darling River floodplain and into the main channel. The last of the floodwater is between Pooncarie and Burtundy (right). Dissolved oxygen monitoring results from the lower Darling River are listed in Table 2.

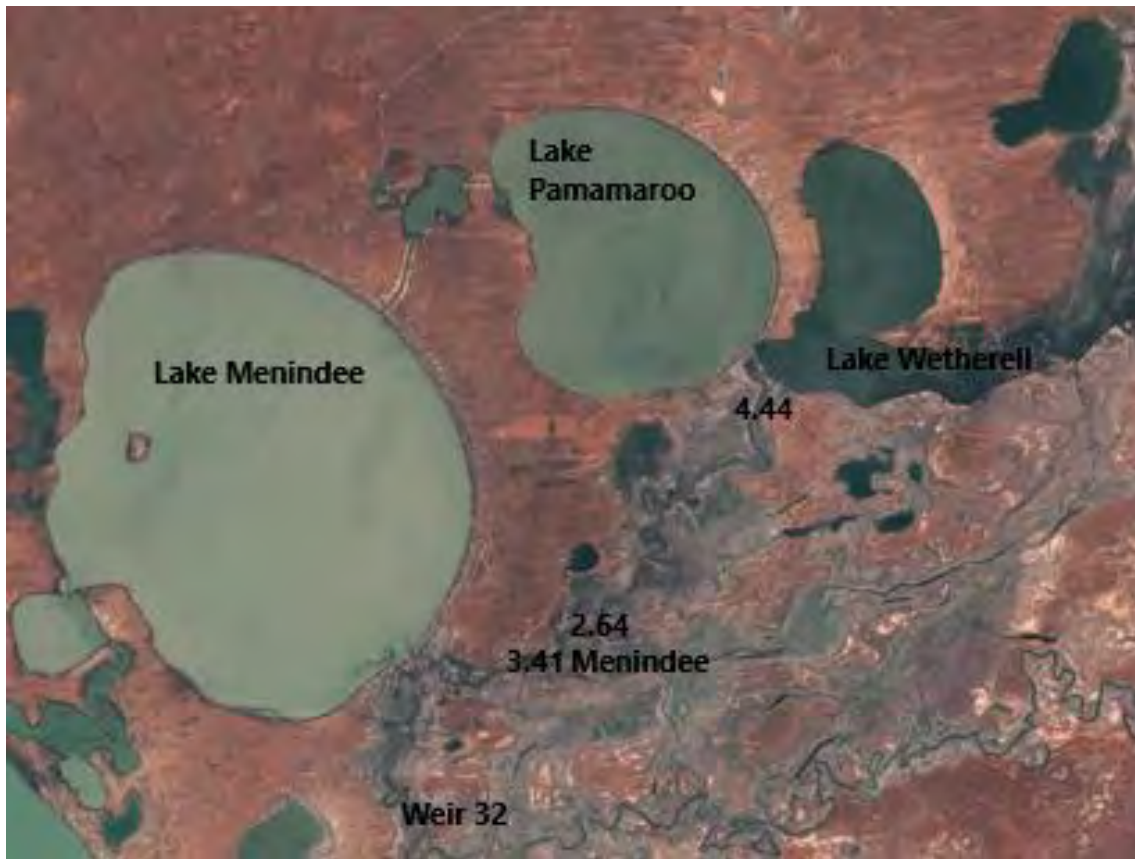
Figure 472: Satellite derived Sentinel image – Image 19 March. Data collected 17 March (mg/L)

Figure 472 and Figure 473 are satellite-derived Sentinel images showing the Darling River and Menindee Lakes at Menindee on 19 March. Dissolved oxygen monitoring results (mg/L) collected on 17 and 20 March.

Site	Sample time	Dissolved oxygen (mg/L)	Water temp (°C)
Darling River downstream of Main Weir	17/03/2023 13:50	4.44	24.1
Darling River near Railway line	17/03/2023 14:10	2.64	25.2
Darling River at Menindee town	17/03/2023 14:18	3.41	25.1
Darling River downstream of Main Weir	20/03/2023 10:24	2.0	24.6
Darling River near Railway line	20/03/2023 10:50	0.51	24.7
Darling River at Menindee town	20/03/2023 10:59	0.73	25.0

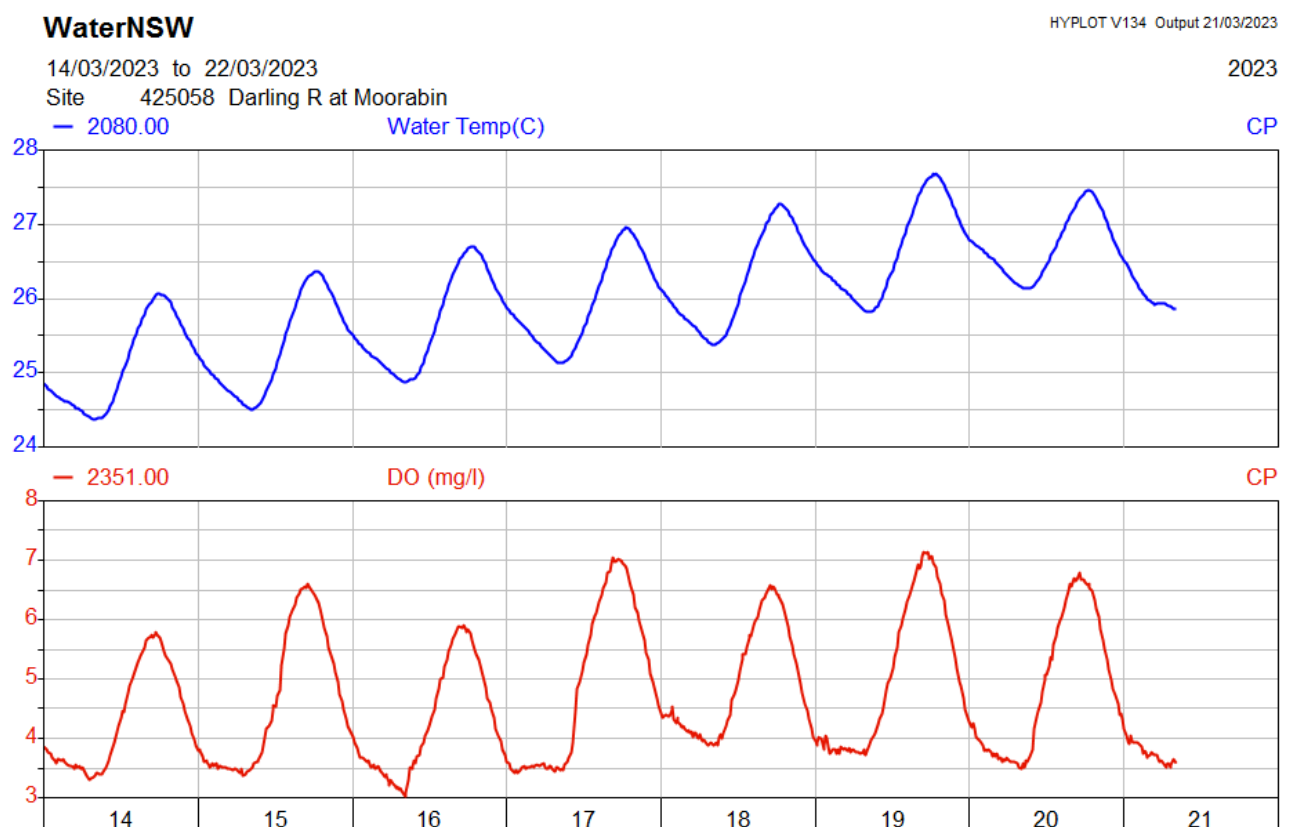
Figure 481: Continuous dissolved oxygen (mg/L) and water temperature (°C) in the Darling River at Wilcannia (Moorabin)

Water temperature increased in response to the heatwave conditions experienced from Friday 17 March through to Sunday 19 March but has started to decrease. The amount of dissolved oxygen water can hold decreases with increasing water temperature which can add additional stress to fish that may already be struggling.

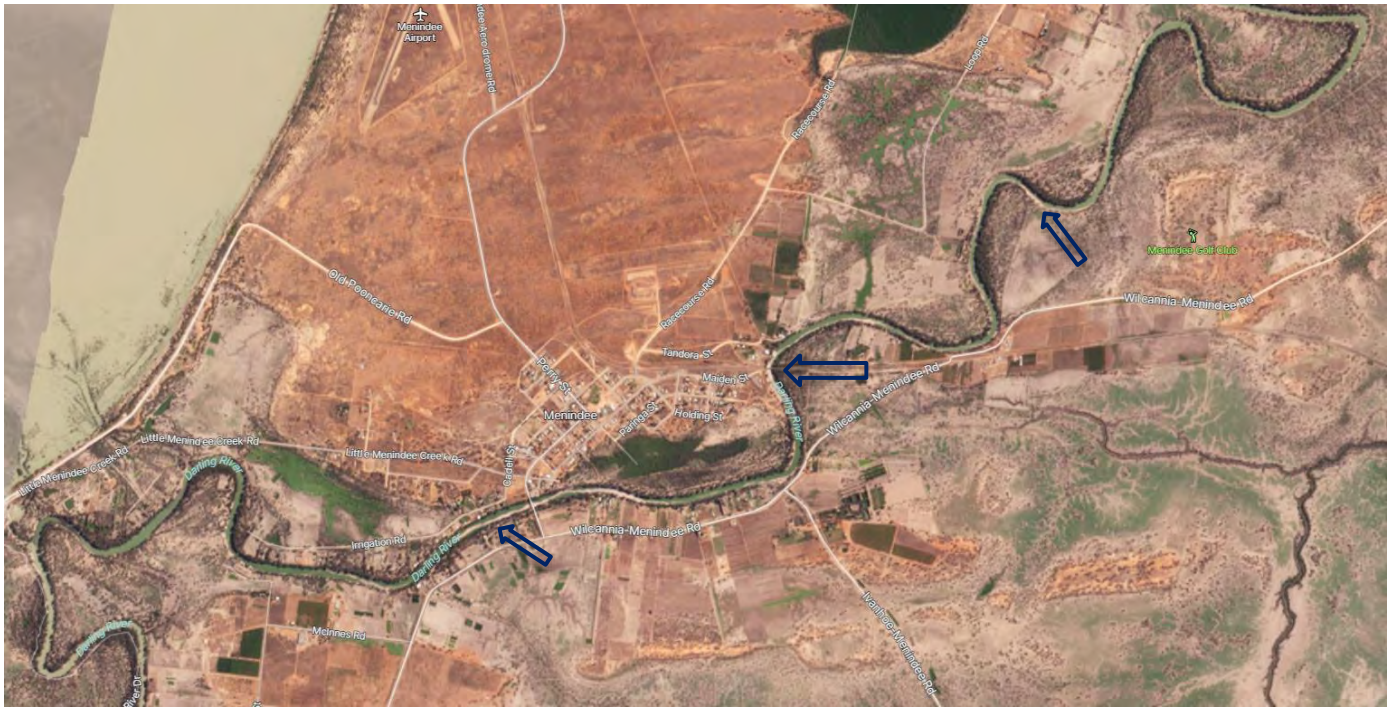
Figure 483: Planet satellite image from 17 March 2023 showing dead fish accumulating along the banks of the Darling River at Menindee

Planet satellite imagery taken on 17 March (Figure 483) shows dead fish accumulating along the banks of the Darling River through Menindee town. Imagery from 19 March shows there is not the same extent of dead fish along the banks but there is an accumulation of dead fish at the junction of the Darling River and Menindee Creek.

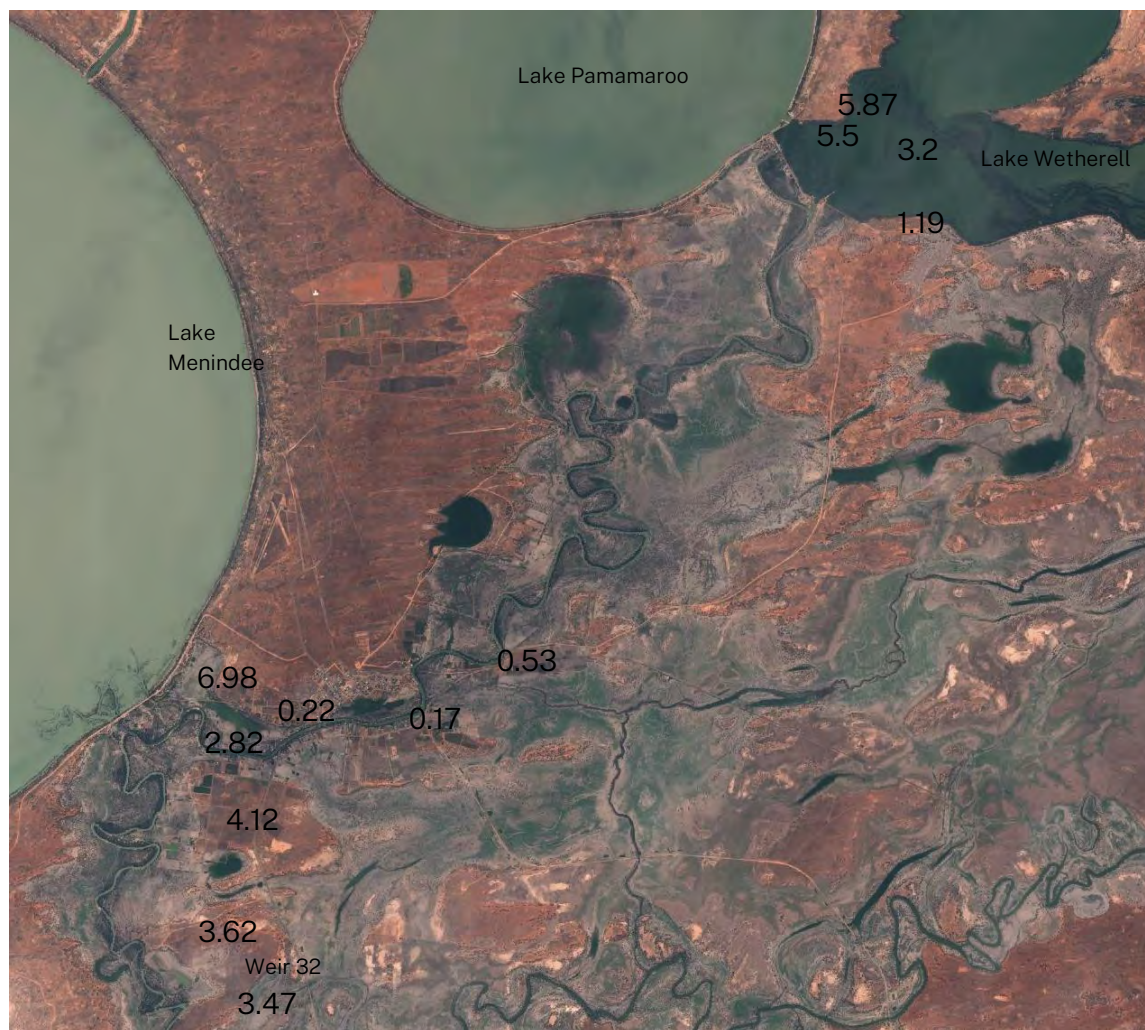
Figure 485: Satellite derived Sentinel image – Image 19 March. Data collected 21 March (mg/L)

Figure 485 is a satellite-derived Sentinel image showing the Darling River and Menindee Lakes at Menindee on 19 March. Dissolved oxygen monitoring results (mg/L) collected by WaterNSW and NSW Fisheries on 21 March are shown on Figure 485 with all water quality parameters included in Table 48.

Dissolved oxygen in the water being released from lakes Pamamaroo and Menindee is above the safe threshold for fish health. The lowest readings are in the Darling River from downstream of Main Weir (1.19 mg/L) through to Menindee town (0.17 mg/L). Dissolved oxygen levels improve downstream of the inflow of more oxygenated water from Lake Menindee via Menindee Creek. The dissolved oxygen result from Weir 32 is higher than the readings from the continuous sensor at the gauging station (Figure 486). The sensor at Weir 32 is set at affixed depth lower in the profile. Oxygen levels can be higher near the water surface than closer to the bottom of pools.

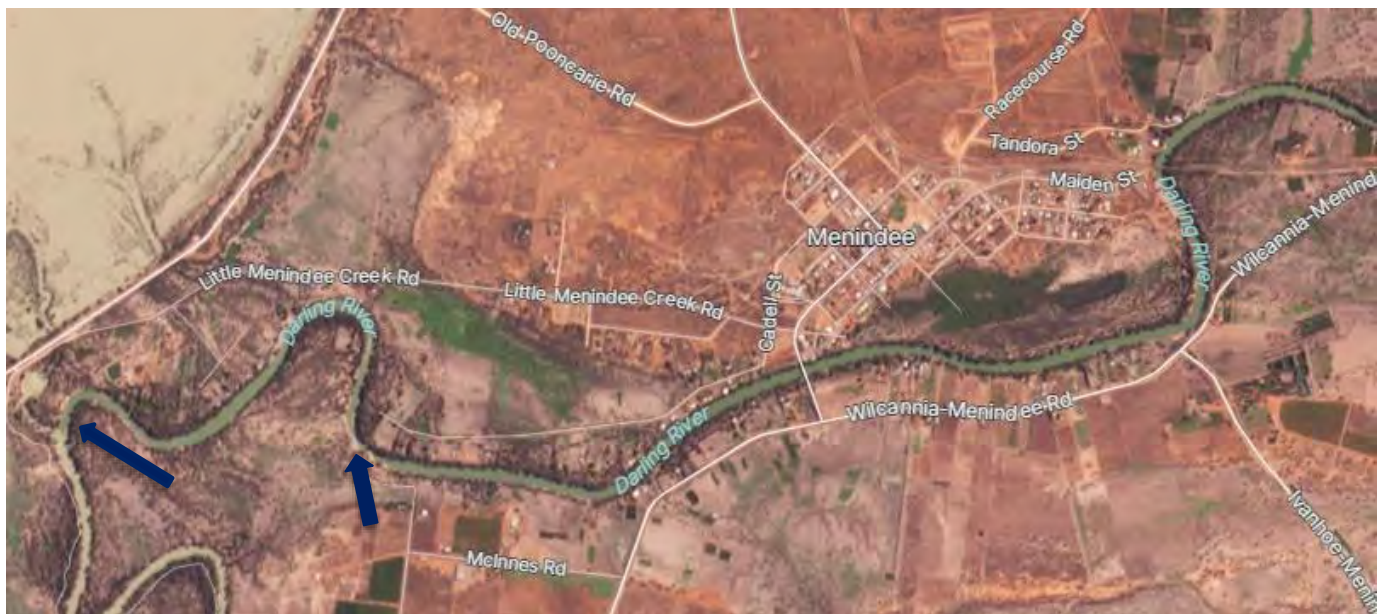
Figure 492: Planet satellite image from 21 March 2023 showing the accumulation of dead fish that was at the junction of the Darling River and Menindee Creek has been dispersed

Planet satellite imagery taken on 19 March showed an accumulation of dead fish upstream of the junction of the Darling River and Menindee Creek. Figure 492 is an image taken on 21 March which shows the accumulation of dead fish has dispersed. There still appears to be dead fish concentrating along the banks in some areas.

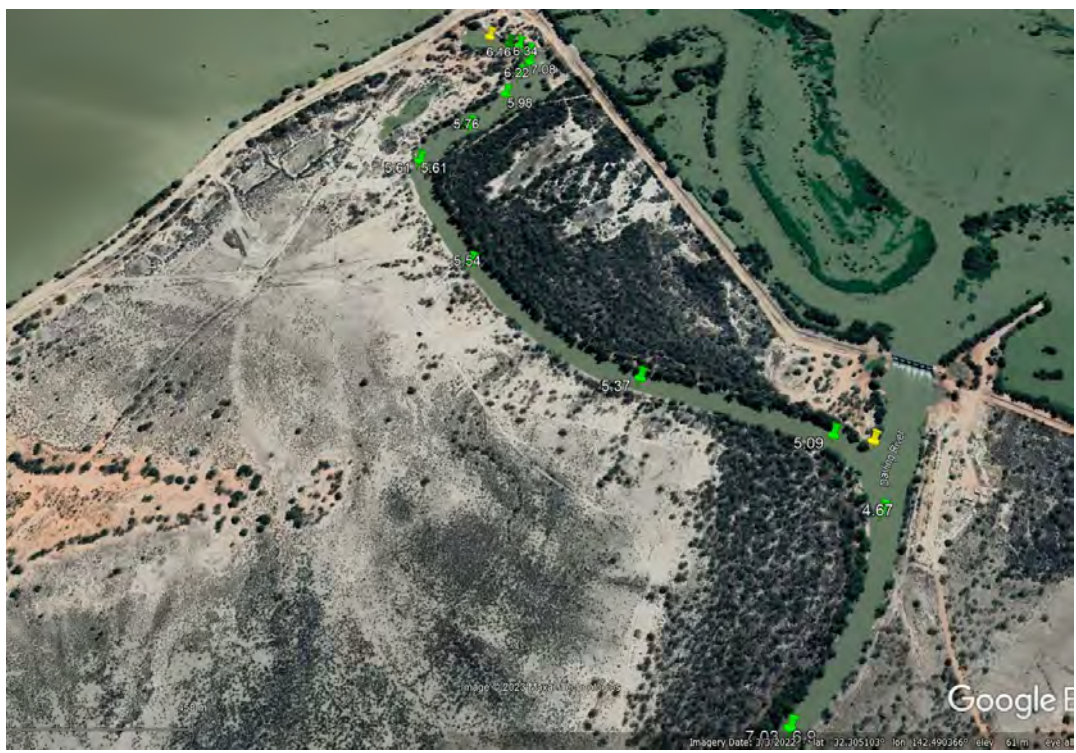
Figure 503: Google Earth image showing dissolved oxygen results from the Lake Pamamaroo outlet to downstream of Main Weir - 25 March

Figure 503 is a Google Earth image showing the location and results from a survey of dissolved oxygen levels down the Darling River on 25 March. There is a drop in oxygen levels from 6.34 mg/L near the Pamamaroo outlet to 4.67 mg/L just downstream of Main Weir.

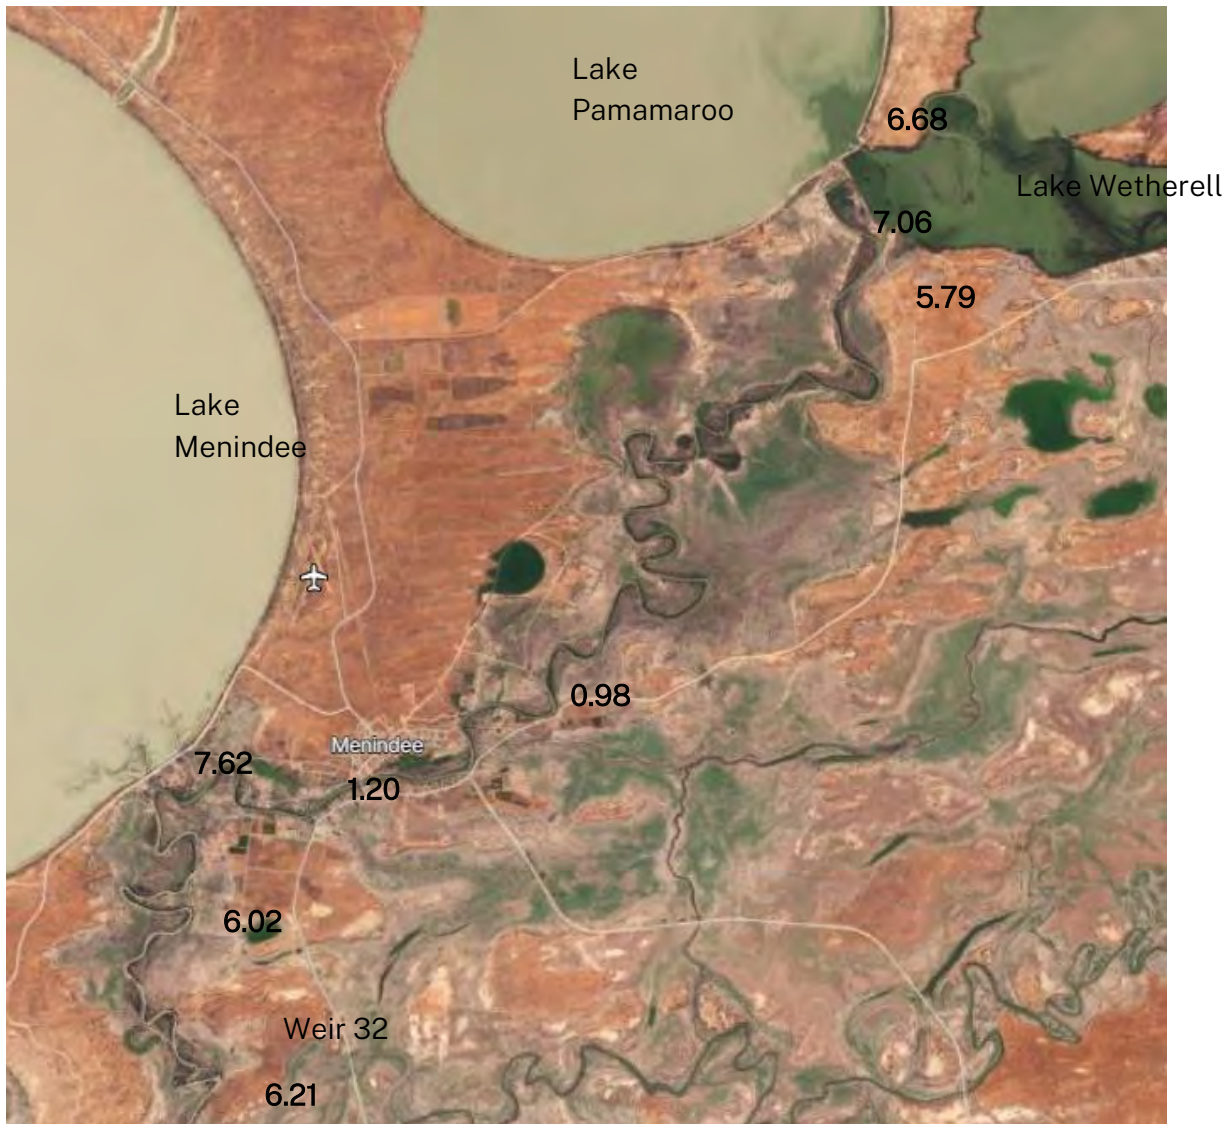
Figure 505: Planet satellite image – Image 25 March. Dissolved oxygen data collected 26 March (mg/L)

Profile readings collected upstream and downstream of the junction of the Darling River with Menindee Creek show that releases from Lake Menindee are continuing to dilute and mix the low oxygen water coming down the Darling River from Menindee town.

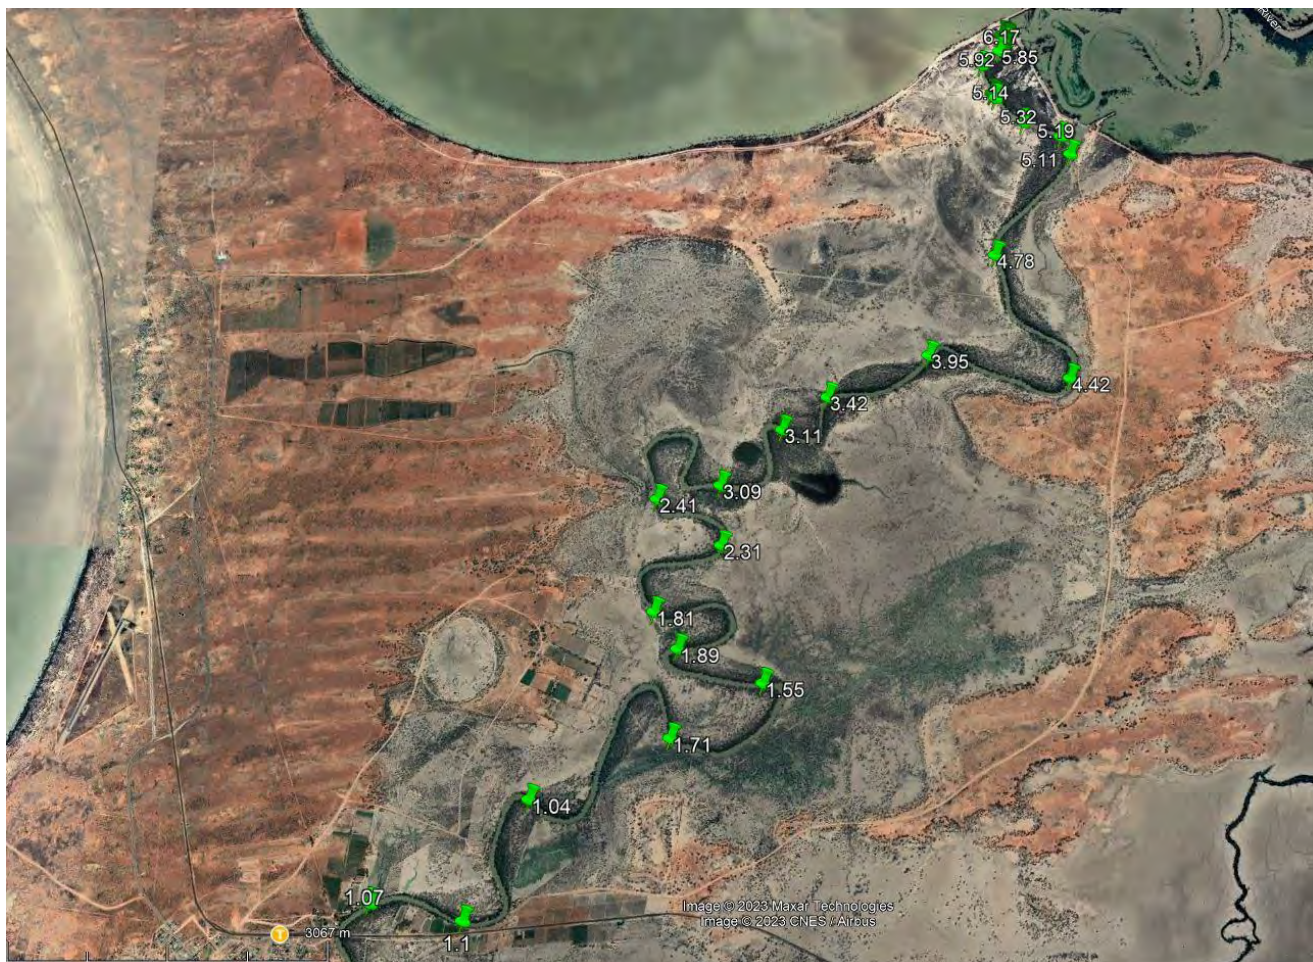
Figure 517: Google Earth image showing dissolved oxygen results from the Lake Pamamaroo outlet to the Rail Bridge upstream of Menindee - 29 March 2023

Figure 517 is a Google Earth image showing the location and results from a survey of dissolved oxygen levels down the Darling River from the Lake Pamamaroo outlet to the Rail Bridge at Menindee on 29 March. There is a steady drop in oxygen levels from 6.17 mg/L near the Pamamaroo outlet down to 1.07 mg/L at the Rail Bridge just upstream of Menindee.

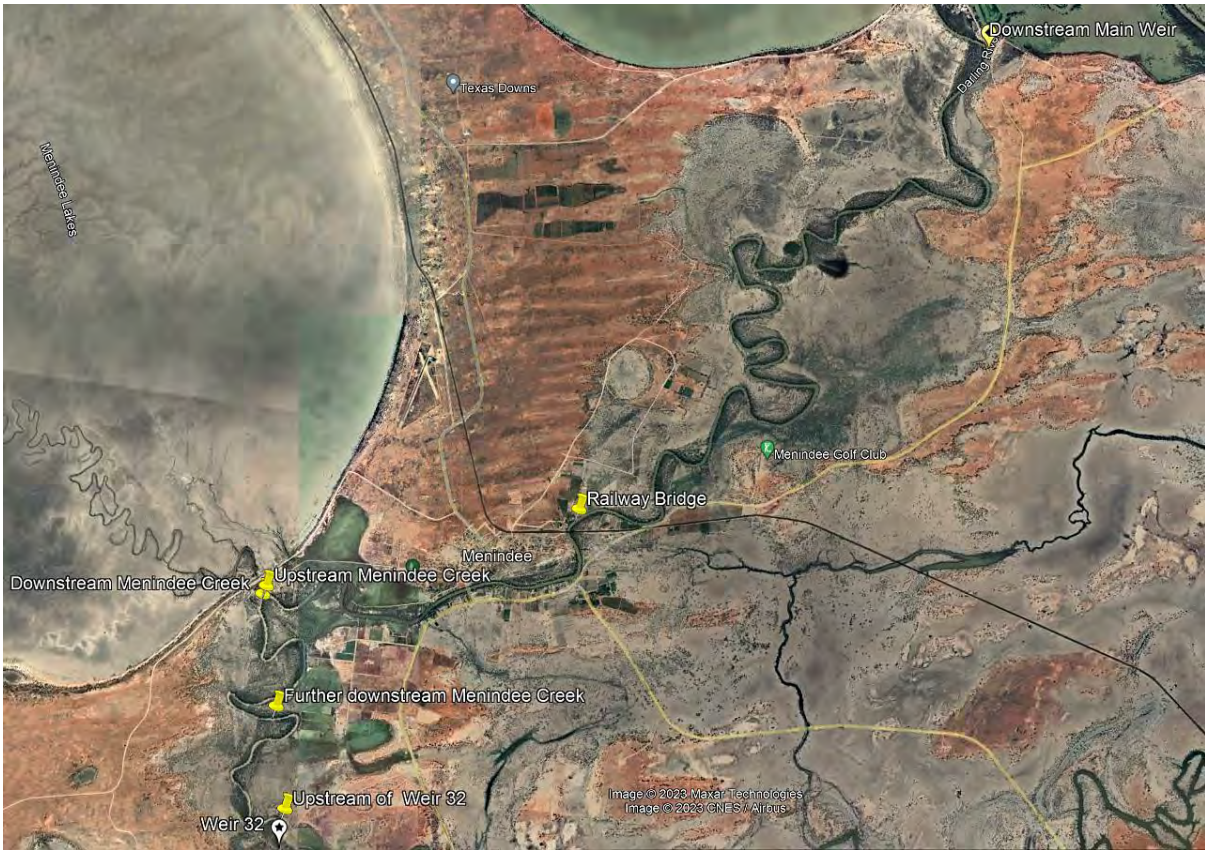
Figure 528: Menindee depth profile sampling locations

Figure 528 is a Google Earth image showing the depth profile sampling locations at Menindee.

Currently oxygenated water is being released into the Darling River from Lake Pamamaroo. Dissolved oxygen levels are decreasing to critical levels for fish health between the Main Weir and the Railway Bridge and upstream of the Darling River and Menindee Creek Junction.

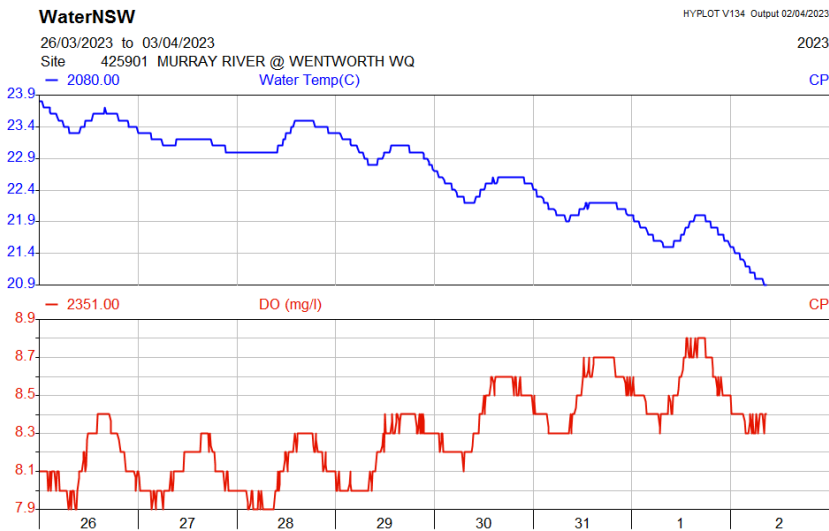
Figure 538: Continuous discharge (ML/day) and water temperature (°C) in the Murray River at Wentworth

Continuous dissolved oxygen readings in the Murray River at Wentworth have remained above 8 mg/L in the last 4 days, with water temperatures decreasing (Figure 538).

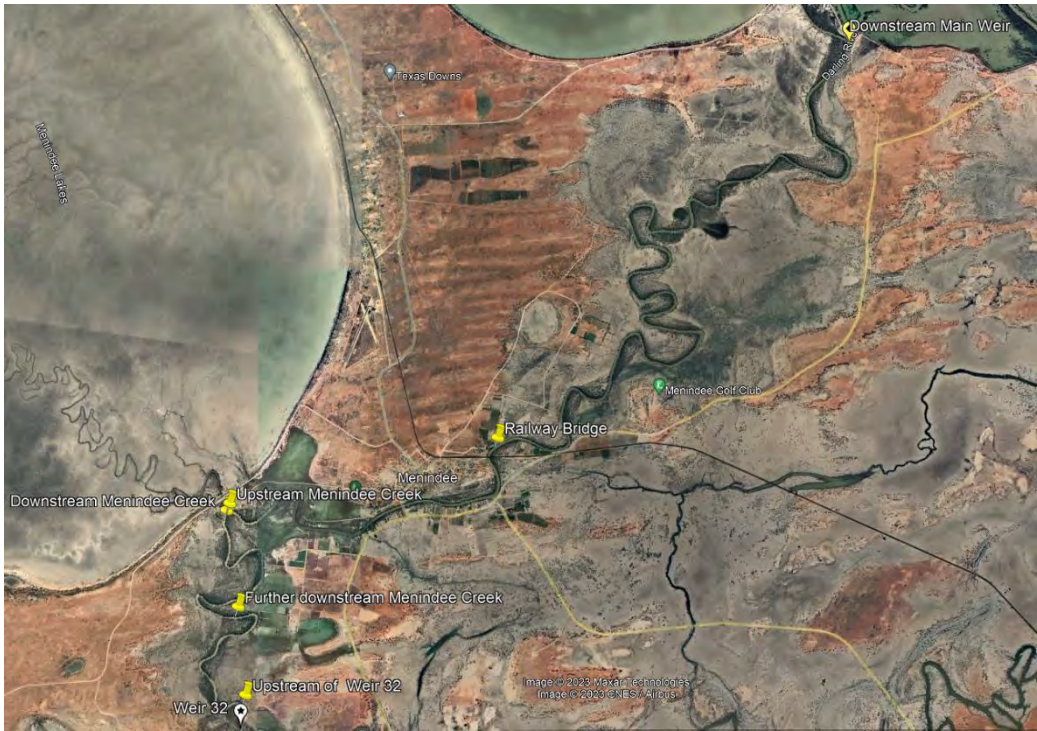
Figure 544: Darling River at Menindee depth profile sampling locations

Figure 544 is a Google Earth image showing the depth profile sampling locations in the Darling River at Menindee.

Currently oxygenated water is being released into the Darling River from Lake Pamamaroo. Dissolved oxygen levels are decreasing to critical levels for fish health between the Main Weir and the Railway Bridge and upstream of the Darling River and Menindee Creek Junction.
