Fish deaths in the Darling–Baaka River – Part B

Part B of the submission to the OCSE independent review into the February to March 2023 fish deaths in the Darling–Baaka River, Menindee

July 2023

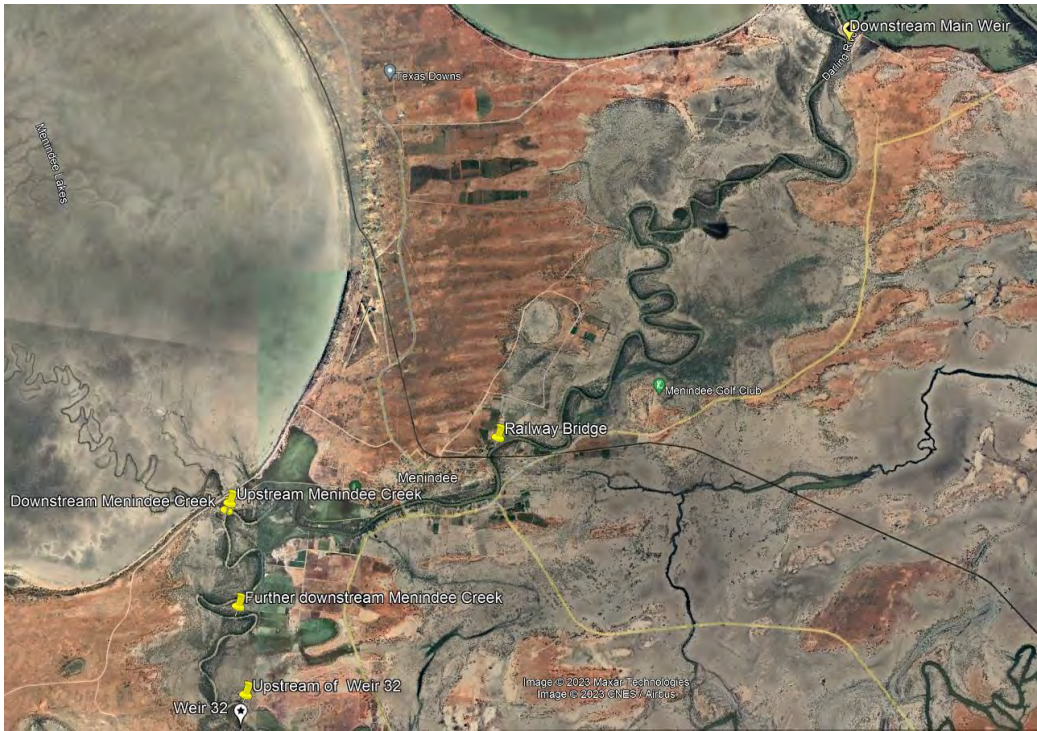
Figure 561 is a Google Earth image showing the depth profile sampling locations in the Darling River at Menindee.

Figure 561: Darling River at Menindee depth profile sampling locations

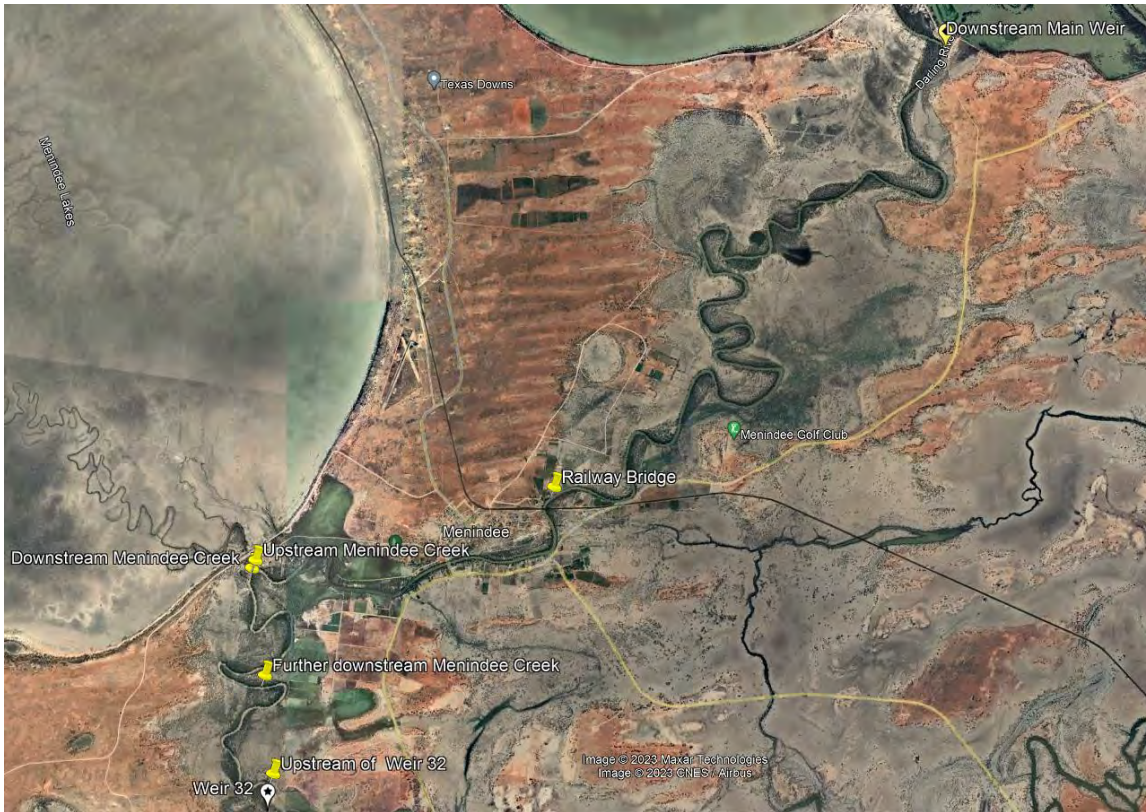
Figure 578 is a Google Earth image showing the depth profile sampling locations in the Darling River at Menindee.

Figure 578: Darling River at Menindee depth profile sampling locations

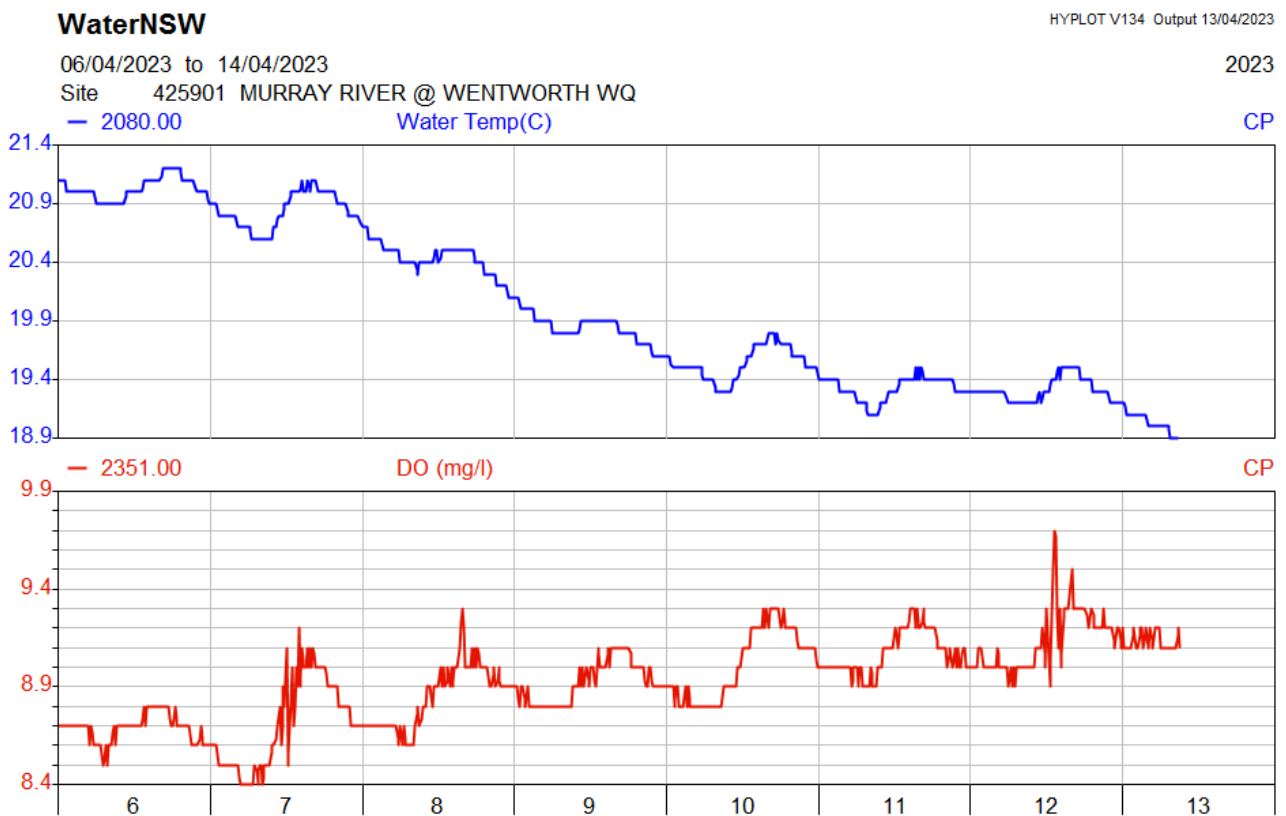
Continuous dissolved oxygen readings in the Murray River at Wentworth have remained above 8 mg/L with water temperatures decreasing (Figure 588).

Figure 588: Continuous discharge (ML/day) and water temperature (°C) in the Murray River at Wentworth

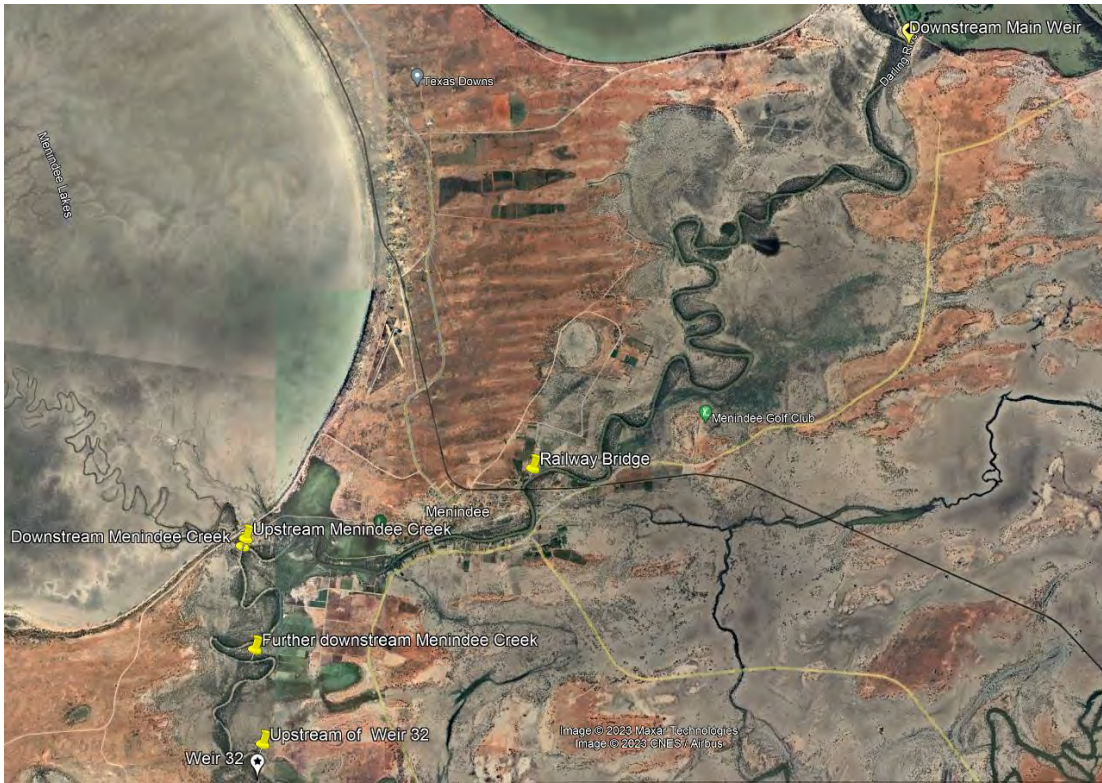
Figure 595 is a Google Earth image showing the depth profile sampling locations in the Darling River at Menindee.

Figure 595: Darling River at Menindee depth profile sampling locations

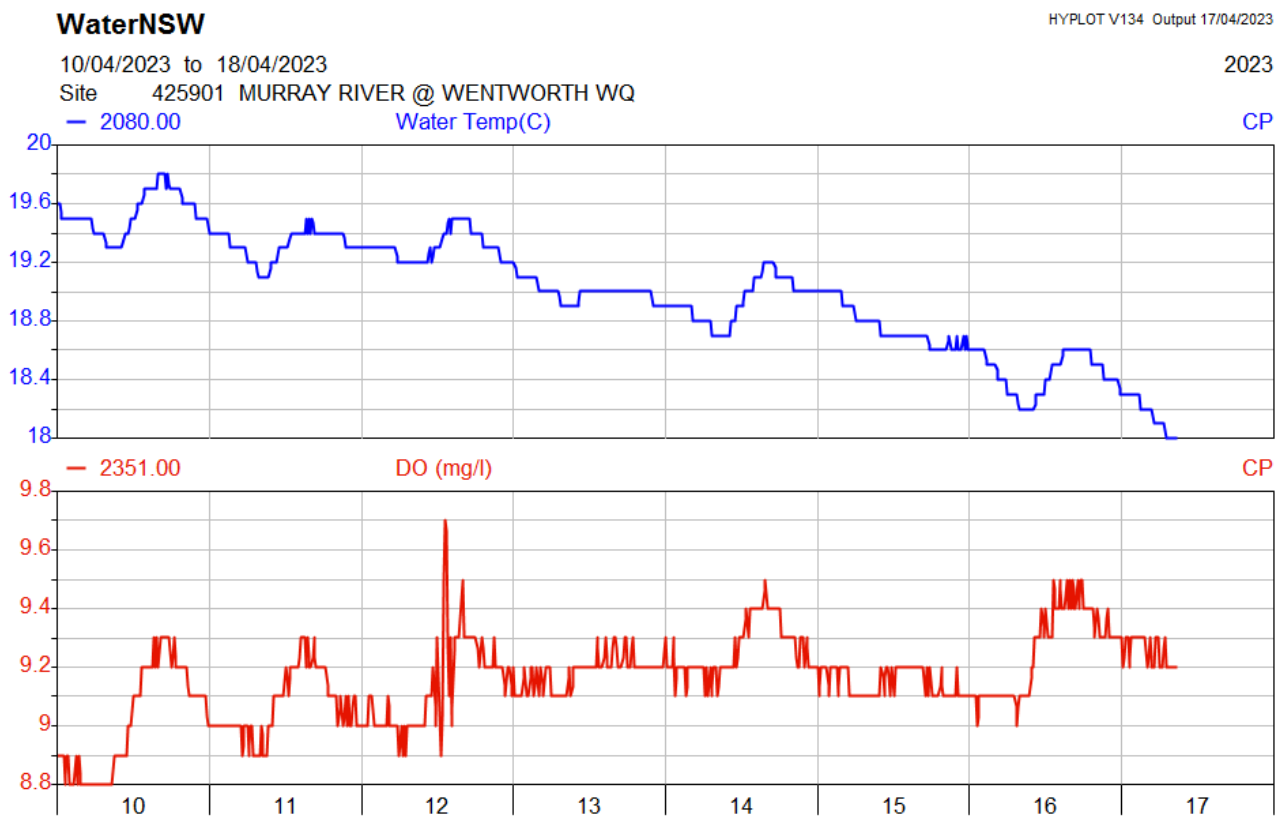
Continuous dissolved oxygen readings in the Murray River at Wentworth have remained above 8 mg/L with water temperatures decreasing (Figure 605).

Figure 605: Continuous discharge (ML/day) and water temperature (°C) in the Murray River at Wentworth

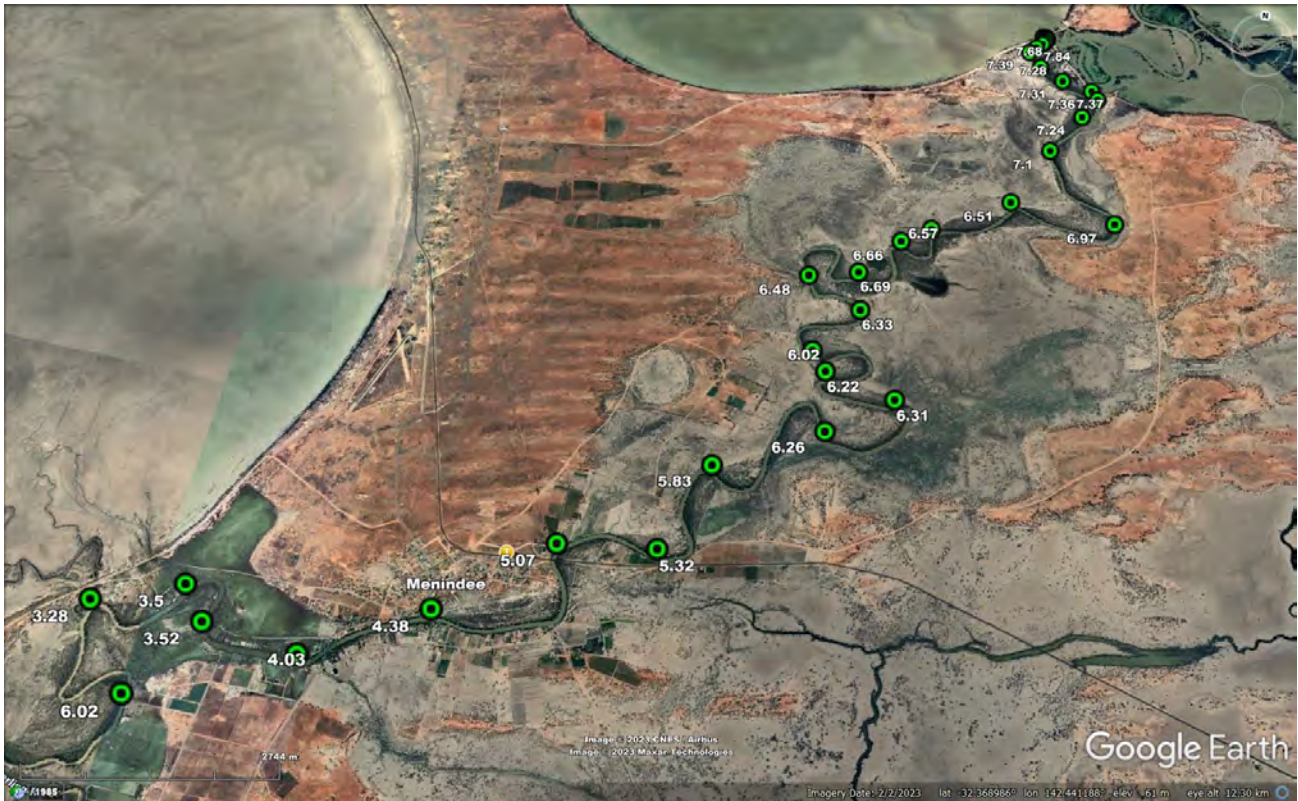
Figure 612 is a Google Earth image showing the location and results from a longitudinal survey of dissolved oxygen levels down the Darling River from the Lake Pamamaroo outlet to the Rail Bridge at Menindee on 20 April. Dissolved oxygen levels are above 4 mg/L at most sites between Lake Pamamaroo and Menindee Creek.

Figure 612: Google Earth image showing dissolved oxygen results from the Lake Pamamaroo outlet to downstream of Menindee Creek – 20 April 2023

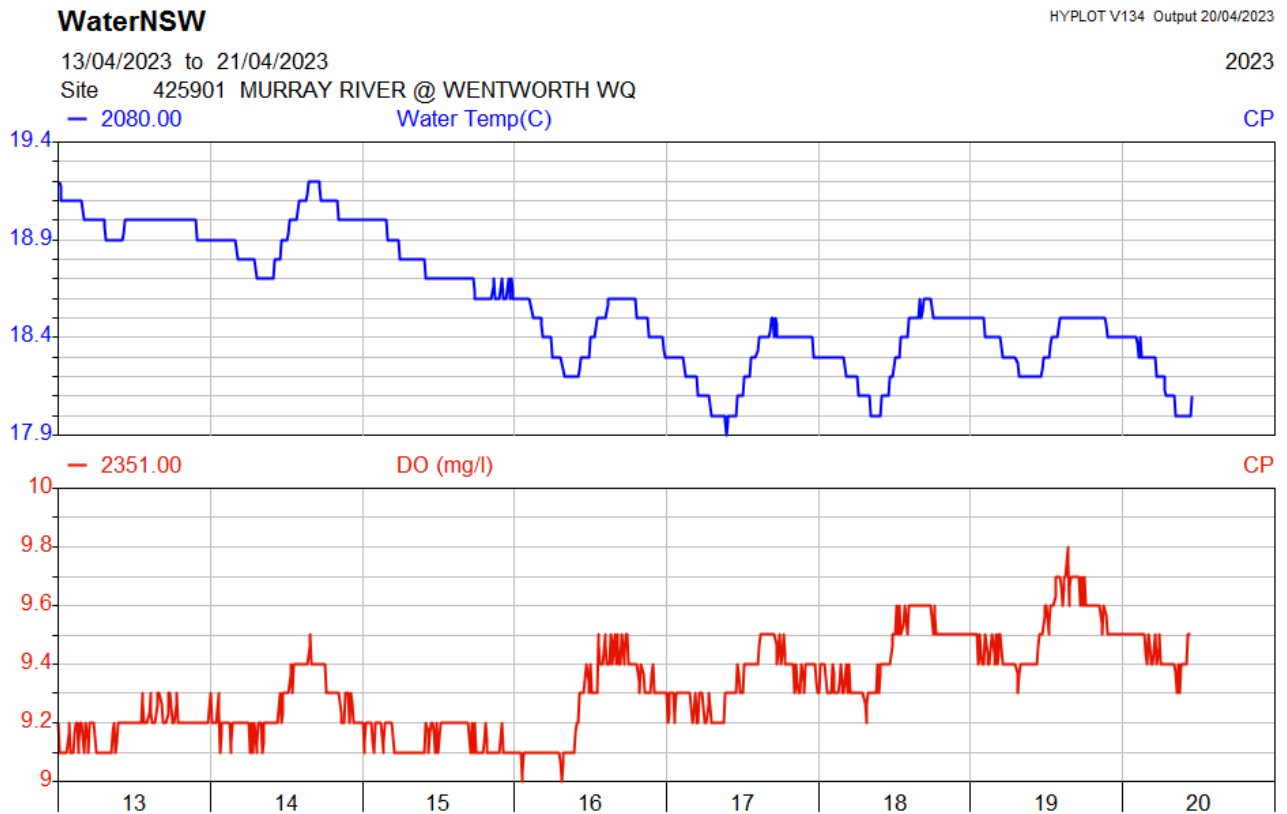
Continuous dissolved oxygen readings in the Murray River at Wentworth have remained above 8 mg/L with water temperatures decreasing (Figure 620).

Figure 620: Continuous discharge (ML/day) and water temperature (°C) in the Murray River at Wentworth

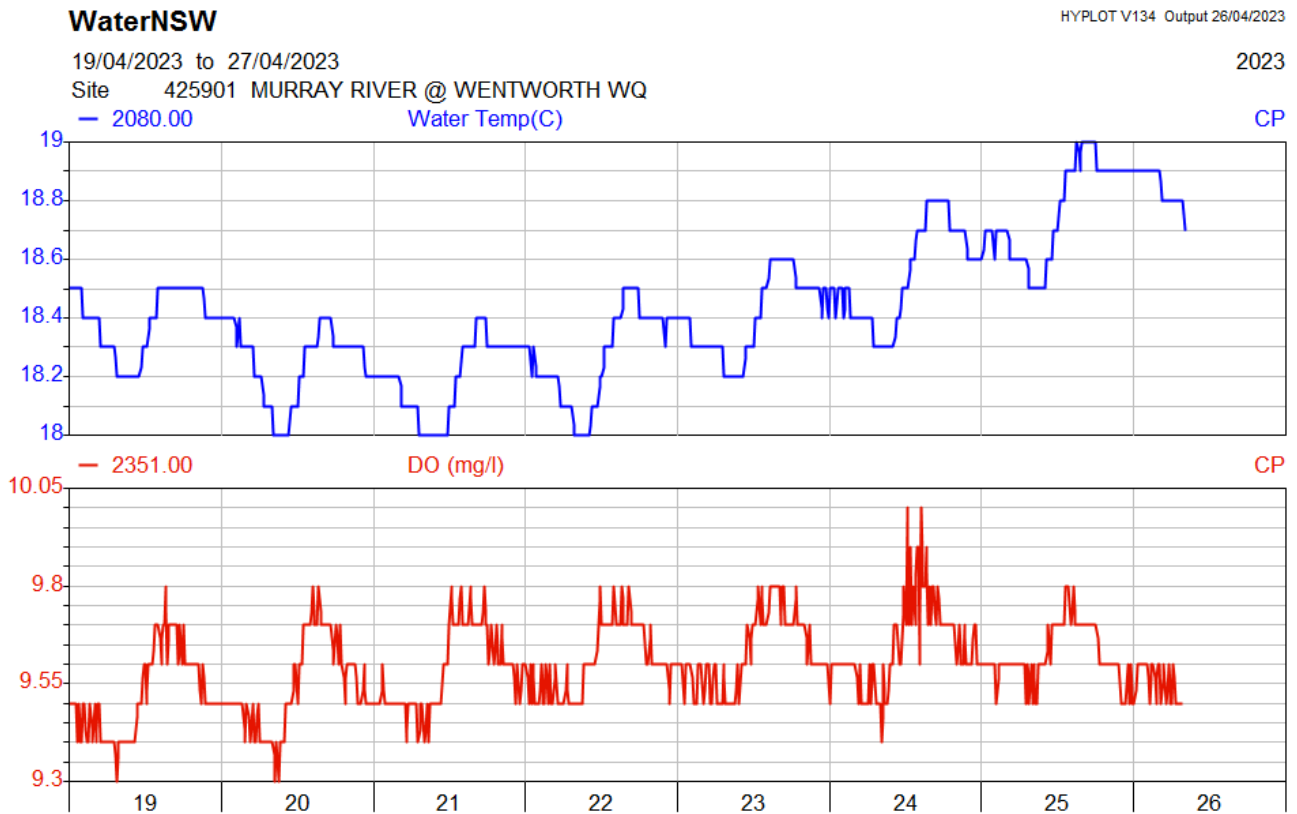
Continuous dissolved oxygen readings in the Murray River at Wentworth are remaining above 9 mg/L (Figure 635).

Figure 635: Continuous discharge (ML/day) and water temperature (°C) in the Murray River at Wentworth

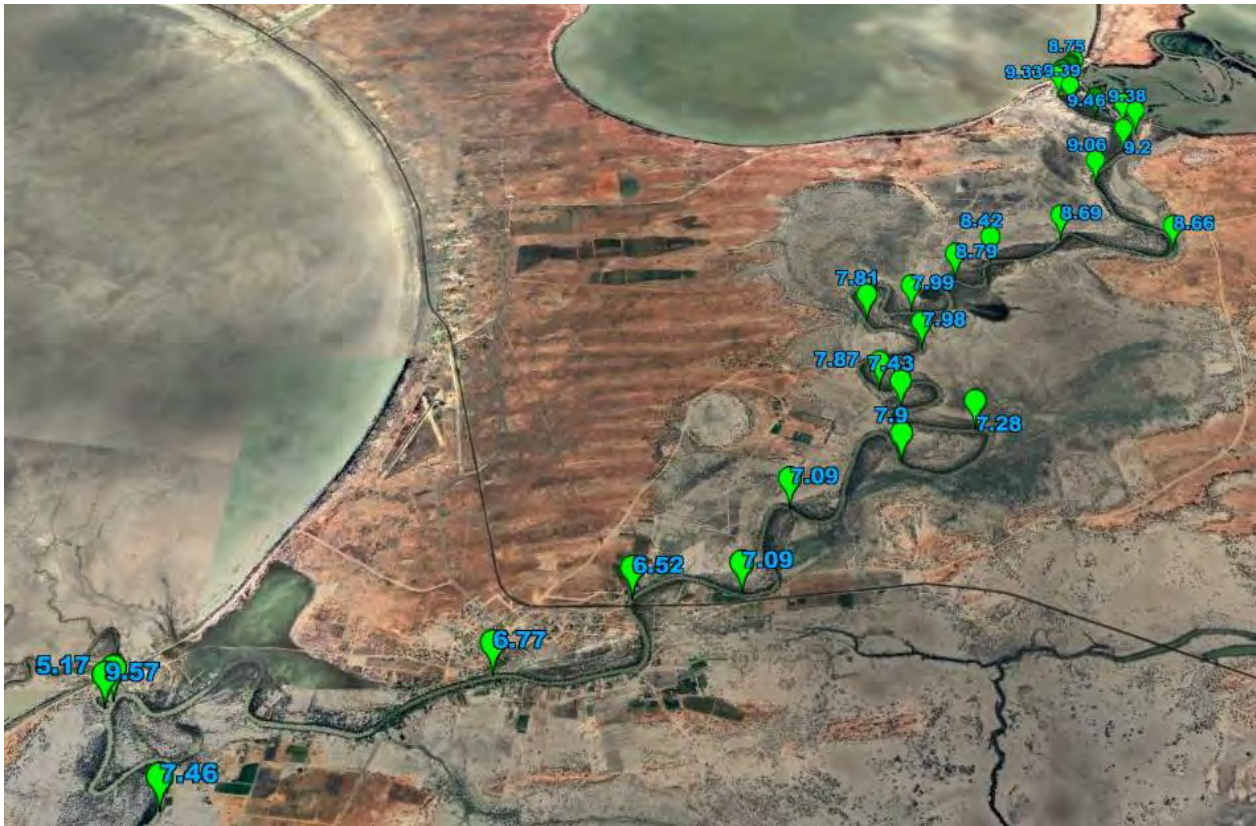
Figure 655 is a Google Earth image showing the location and results from a longitudinal survey of dissolved oxygen levels down the Darling River from the Lake Pamamaroo outlet to downstream of the Darling River-Menindee Creek junction on 15 May. Dissolved oxygen levels are above 4 mg/L at all sites.

Figure 655: Google Earth image showing dissolved oxygen results from the Lake Pamamaroo outlet to downstream of Menindee Creek junction – 15 May 2023

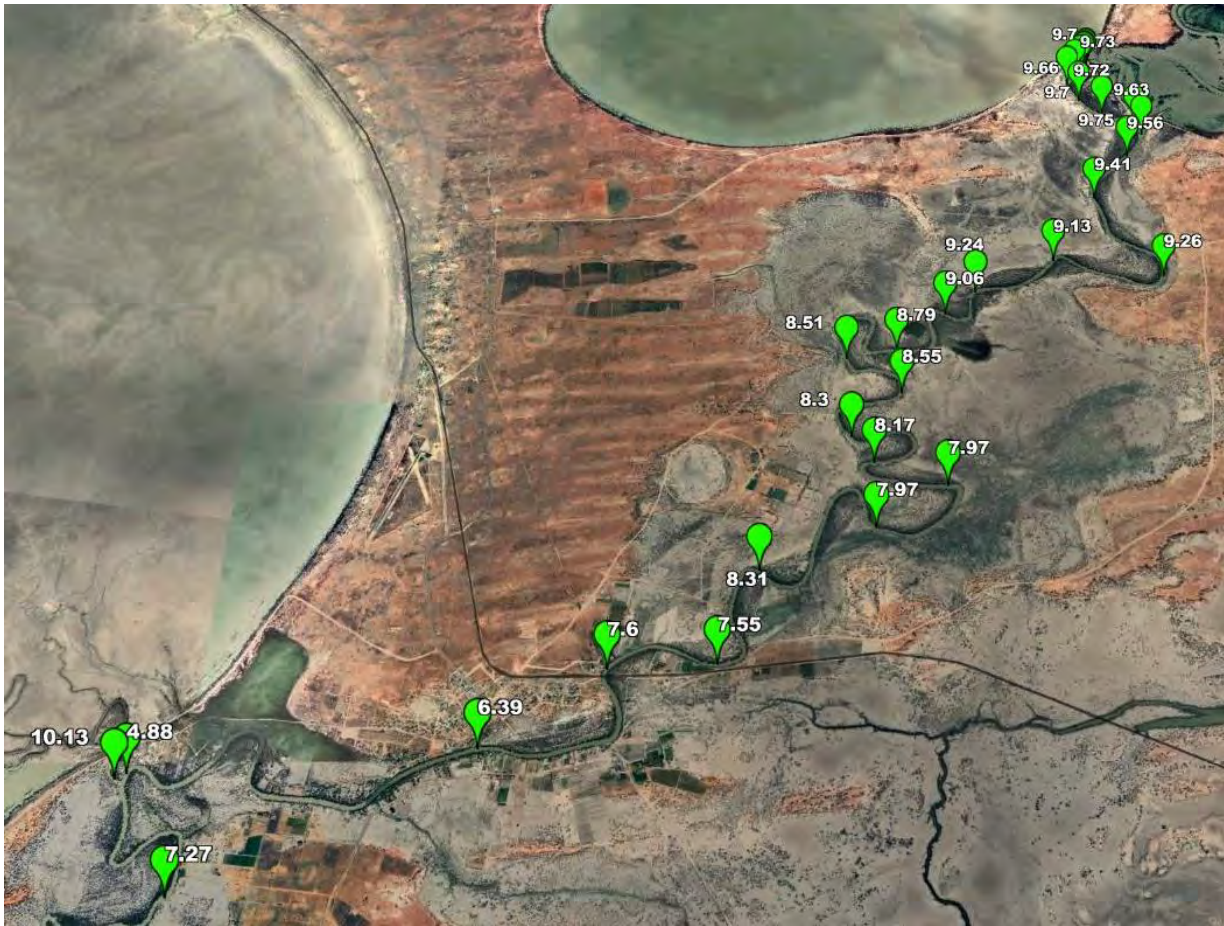
Figure 665 is a Google Earth image showing the location and results from a longitudinal survey of dissolved oxygen levels down the Darling River from the Lake Pamamaroo outlet to downstream of the Darling River-Menindee Creek junction on 25 May. Dissolved oxygen levels are above 4 mg/L at all sites.

Figure 665: Google Earth image showing dissolved oxygen results from the Lake Pamamaroo outlet to downstream of Menindee Creek junction – 25 May 2023

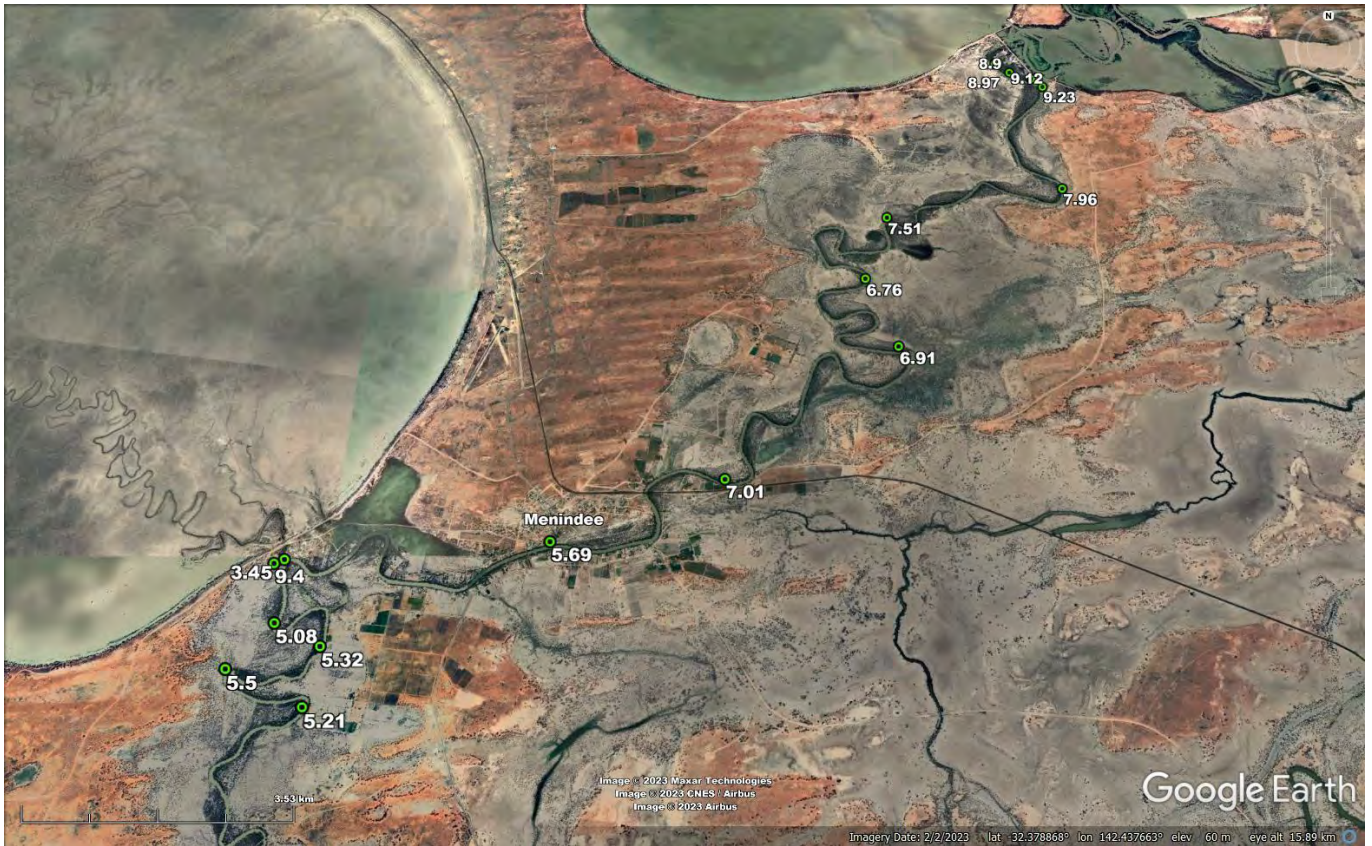
Figure 675 is a Google Earth image showing the location and results from a longitudinal survey of dissolved oxygen levels down the Darling River from the Lake Pamamaroo outlet to downstream of Menindee Creek on 5 & 6 June. Dissolved oxygen levels are above 5 mg/L at all sites except immediately upstream of the Menindee Creek outlet.

Figure 675: Google Earth image showing dissolved oxygen results from the Lake Pamamaroo outlet to Menindee– 5 & 6 June 2023

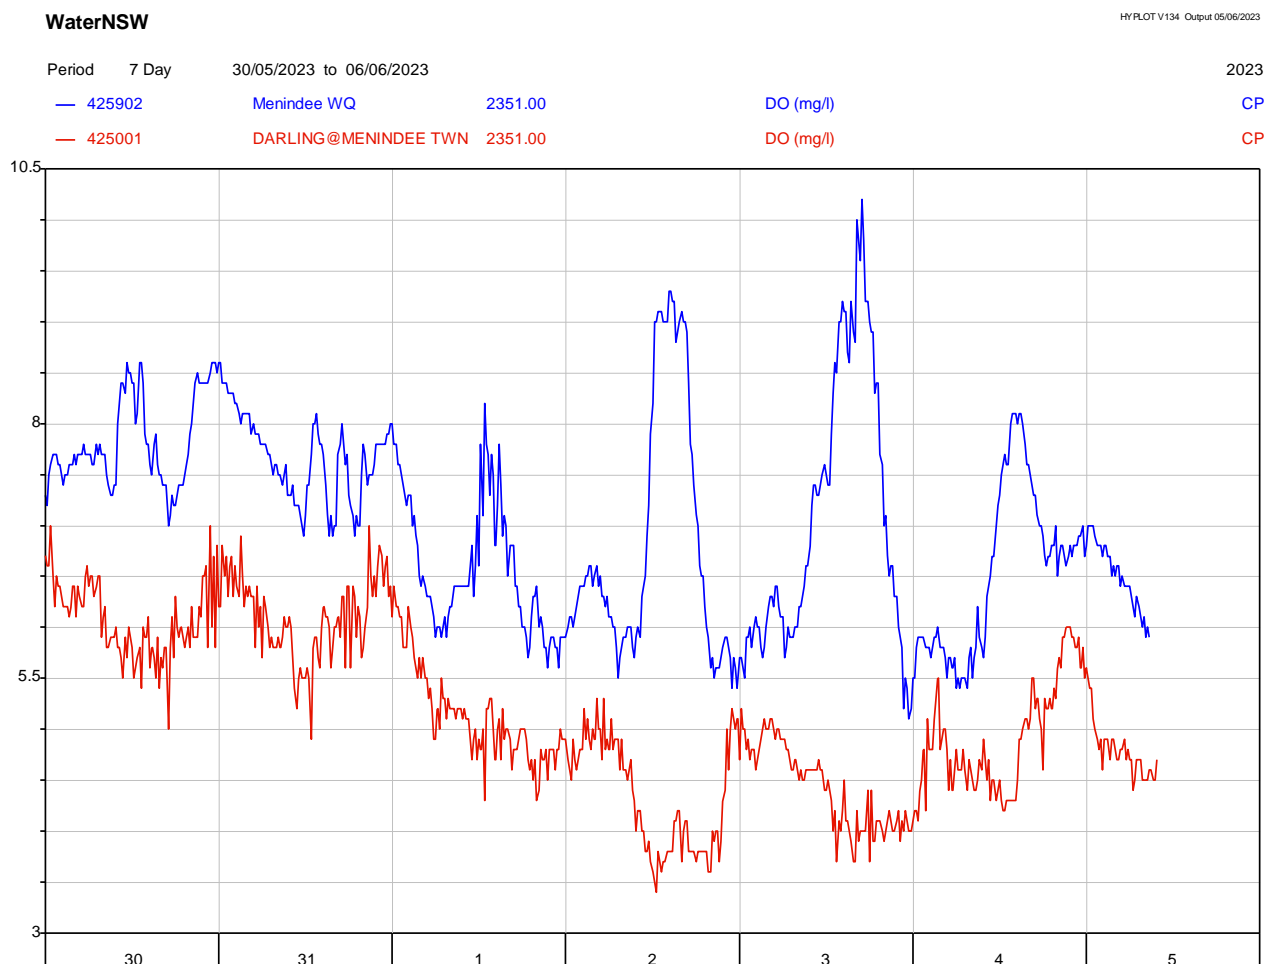
The data from the temporary dissolved oxygen sensor (425902) installed at the Menindee pump station (at a depth of about 1 m from the water surface) is showing consistent dissolved oxygen levels (Figure 677). Overnight dissolved oxygen levels remain above 5 mg/L.

A second dissolved oxygen sensor at the Menindee Town gauging station is showing dissolved oxygen levels near the riverbed. The dissolved oxygen level at Menindee Town has been dropping below 4 mg/L overnight but remains above 4 mg/L during the day. The two sites are approximately 2 km apart by river. Water temperature in this area is around 15°C.

Figure 677: Continuous dissolved oxygen (mg/L) in the Darling River at Menindee pump station and Menindee town gauging stations

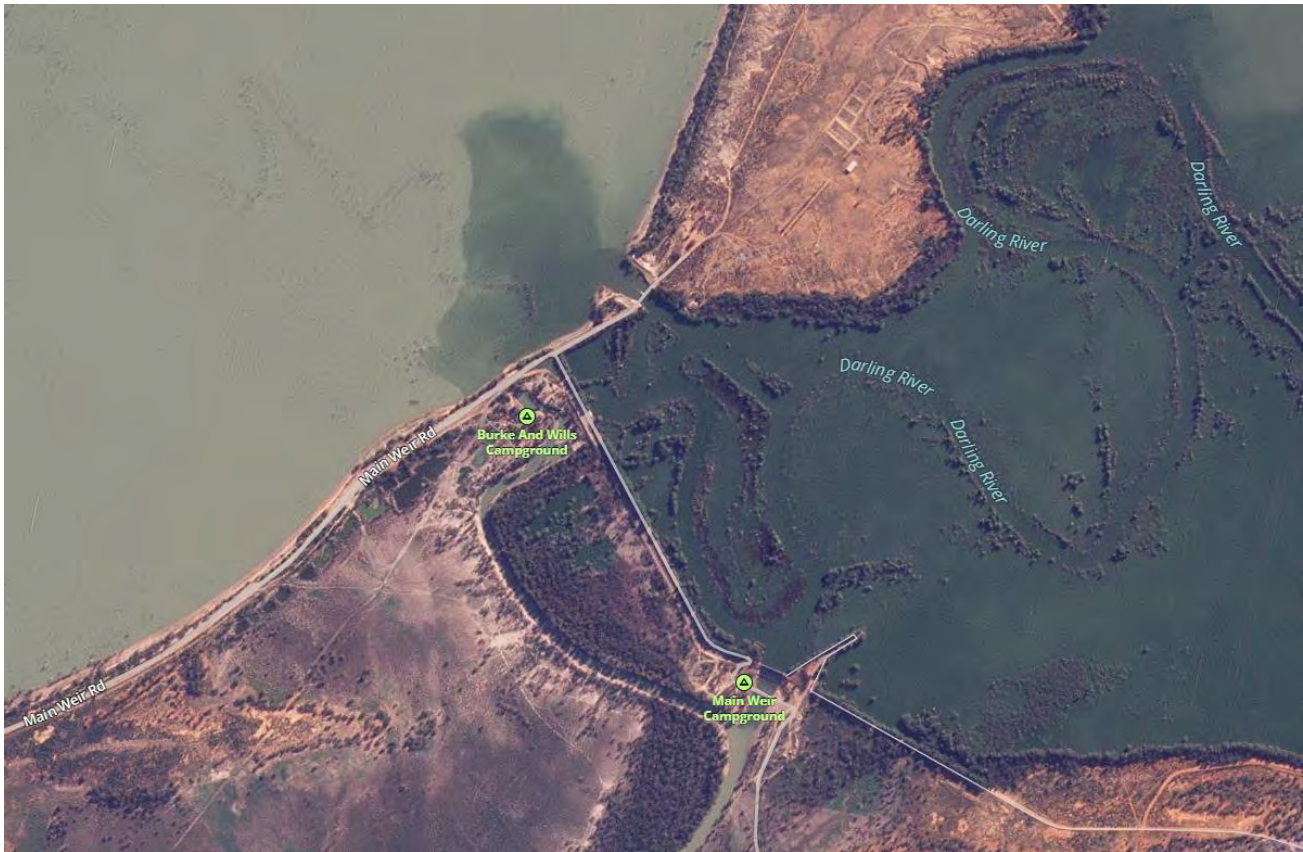
The Pamamaroo inlet has been opened. Figure 684 shows water from Lake Wetherell starting to push into Lake Pamamaroo. The Planet satellite image from 12 June (Figure 685) shows the water from Lake Wetherell is mixing with the water in Lake Pamamaroo. Table 81 lists the dissolved oxygen monitoring results from the Darling River downstream of Lake Wetherell Main Weir. There has been minimal change in dissolved oxygen since the Pamamaroo inlet was opened.

Figure 684: Planet satellite image 9 June

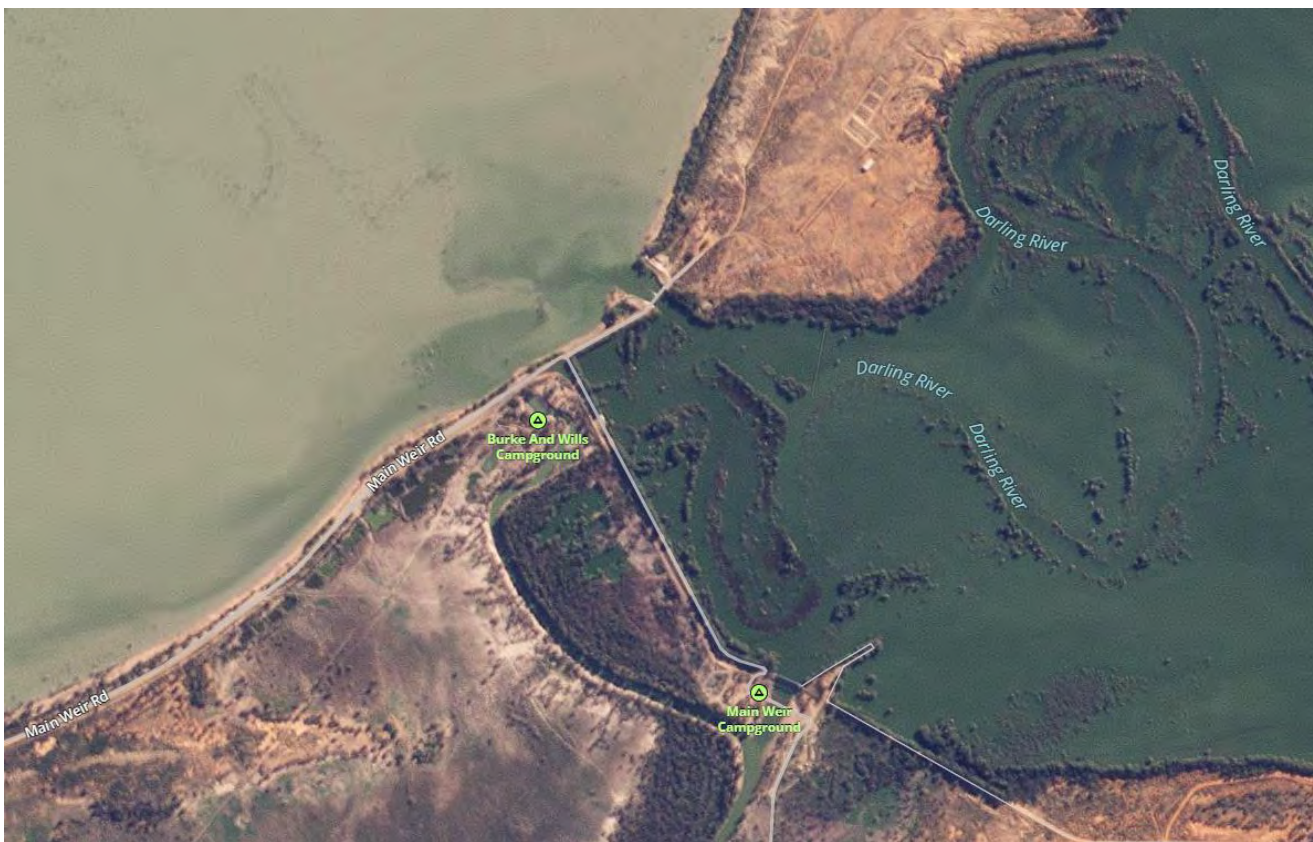
Figure 685: Planet satellite image 12 June

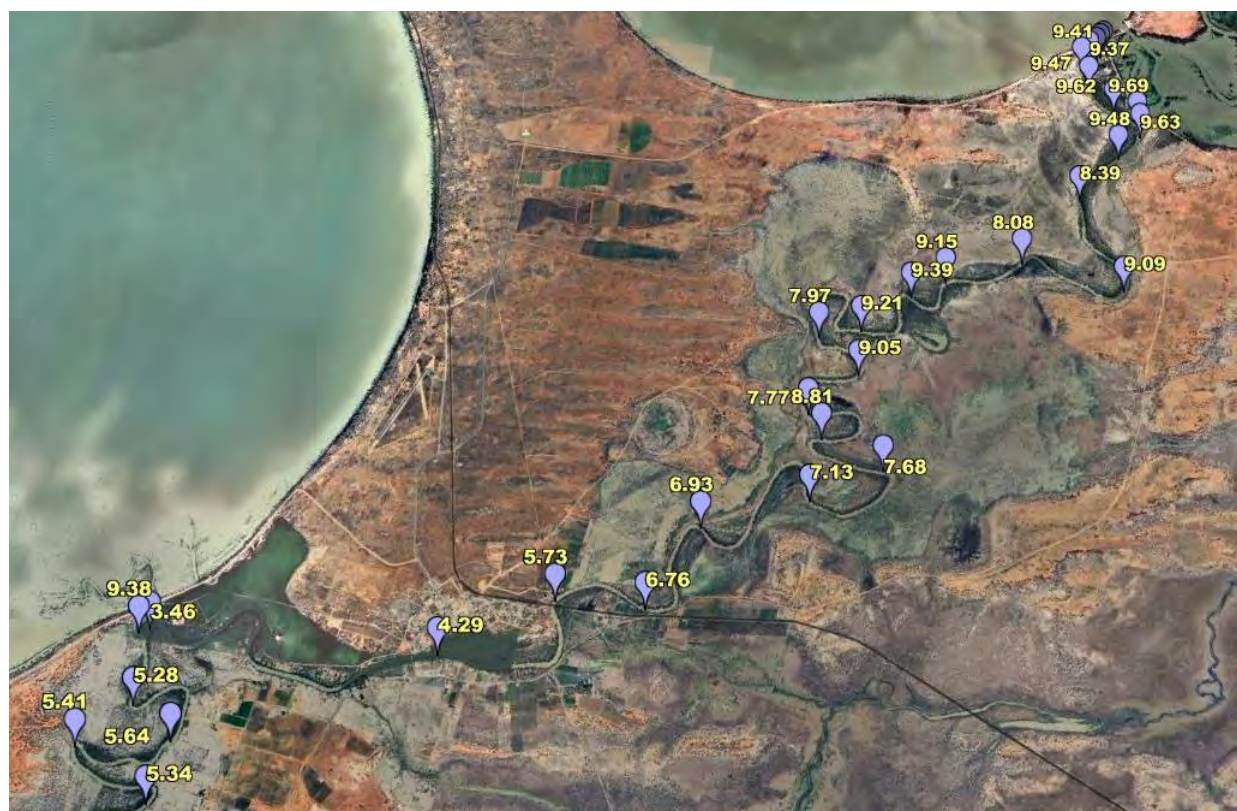
Figure 686 is a Google Earth image showing the location and results from a longitudinal survey of dissolved oxygen levels down the Darling River from the Lake Pamamaroo outlet to downstream of Menindee Creek on 14 June. Dissolved oxygen levels are above 4 mg/L at all sites except immediately upstream of the Menindee Creek outlet (3.46 mg/L). Dissolved oxygen in the Darling River downstream of the Menindee Creek junction toward Weir 32 is remaining above 5 mg/L.

Figure 686: Google Earth image showing dissolved oxygen results from the Lake Pamamaroo outlet to downstream of Menindee Creek-Darling River junction– 14 June 2023
